Energy Loss Study at Liberty Baptist Church Using Infrared Thermography

Sean M. Benham, ARM, ALCM, CIRT Level, CBST

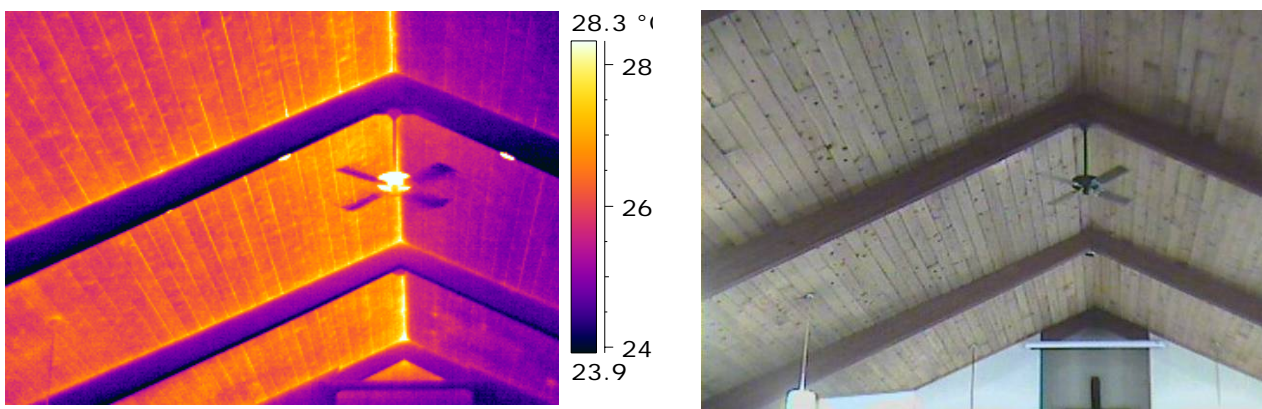
Figure 1 thermogram/photo pair shows the effect of the solar loading on the east face of the roof deck. While the sun at the time of the inspection was facing the west, the east roof deck was still radiating more heat due to having absorbed more energy through the morning and into the early afternoon. This picture also shows the biggest reason as to why this room is difficult to regulate the interior temperature. The interior ceiling deck is also the exterior roof deck. There is no insulating space between the interior and exterior. The only insulation at the roof is the wood itself, the insulating "ISO-Board", and the roofing shingles.

Figure 1. Thermogram/photo pair showing warming of east side of the roof due to solar loading.

One possible remedy for this situation is to install a false interior ceiling with an insulation layer between it and this roof deck. The support beams would provide adequate room for installation of such a false ceiling.

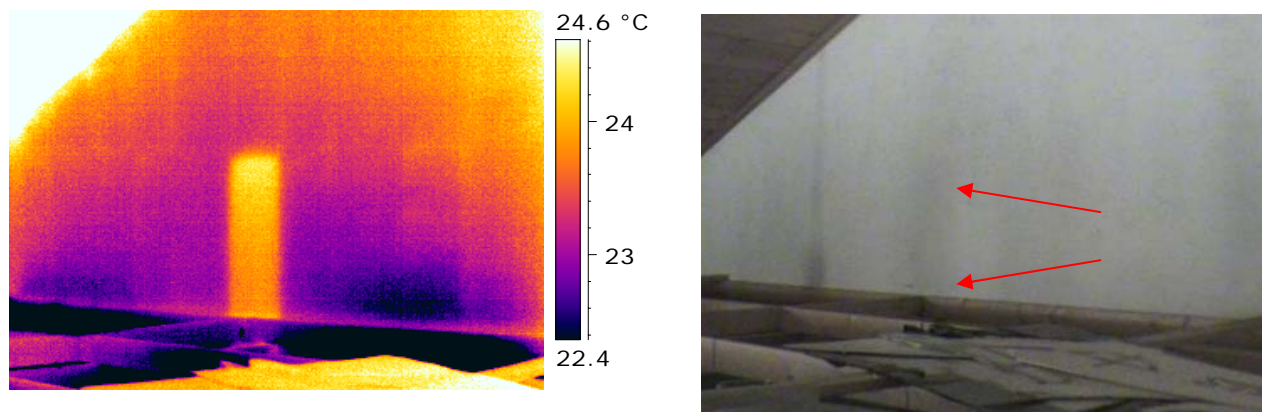
The following images in Figures 2 and 3 show where insulation was either not installed, or has slipped out of place inside the wall cavity. This wall is the north wall and these areas are all located above the false ceiling above the Lobby area.

Figure 2. Thermogram/photo pair shows a warm rectangular region of missing or damaged insulation. The area is along the north wall towards the west edge of the wall.

The remedy for this situation is to either remove the drywall and install new insulation (or repair the existing insulation), or to blow in new insulation into the cavity. Blowing in new insulation may be less intrusive.

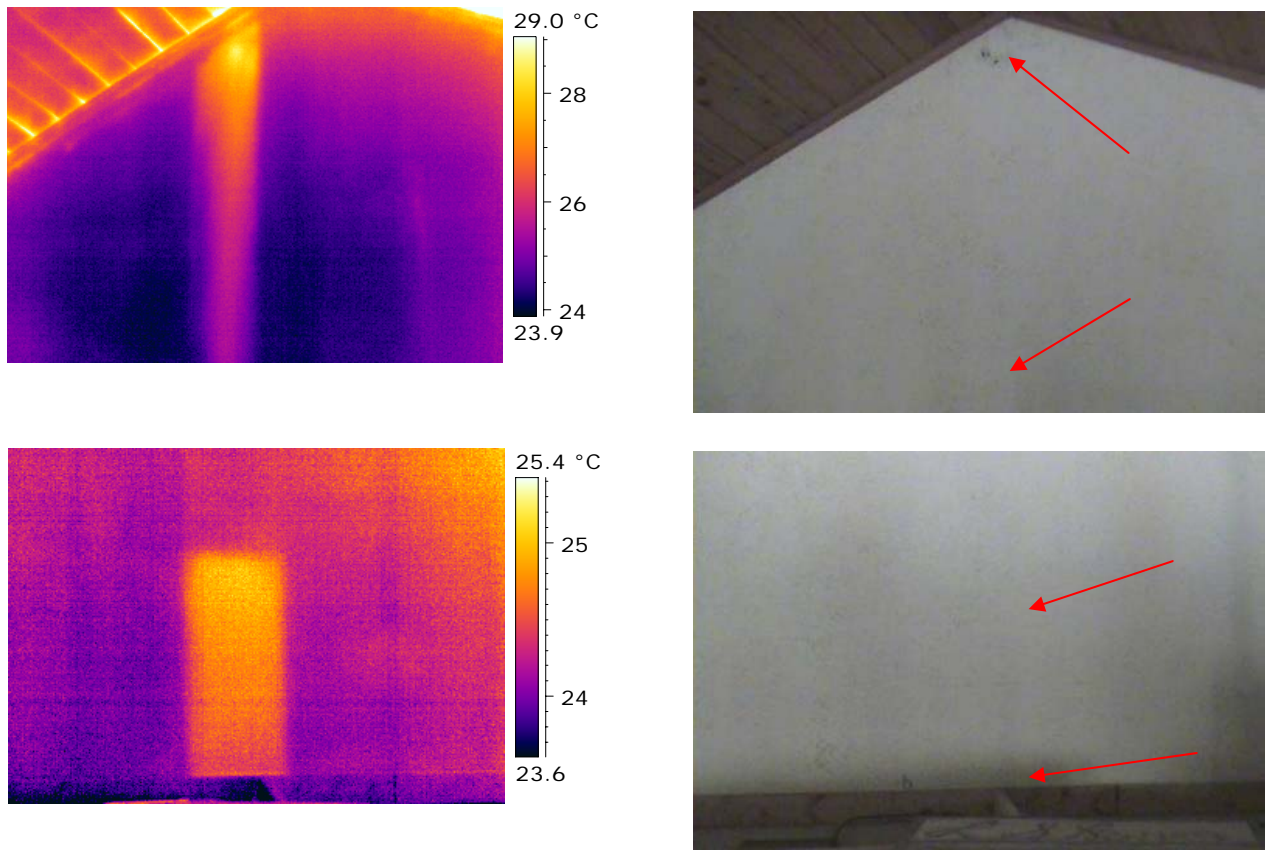
Figure 3. Top IR image and photo show the area of the north wall just west of the peak. Bottom IR image and photo show the north wall along the east edge of the wall. Warmer wall areas indicate missing/damaged insulation.

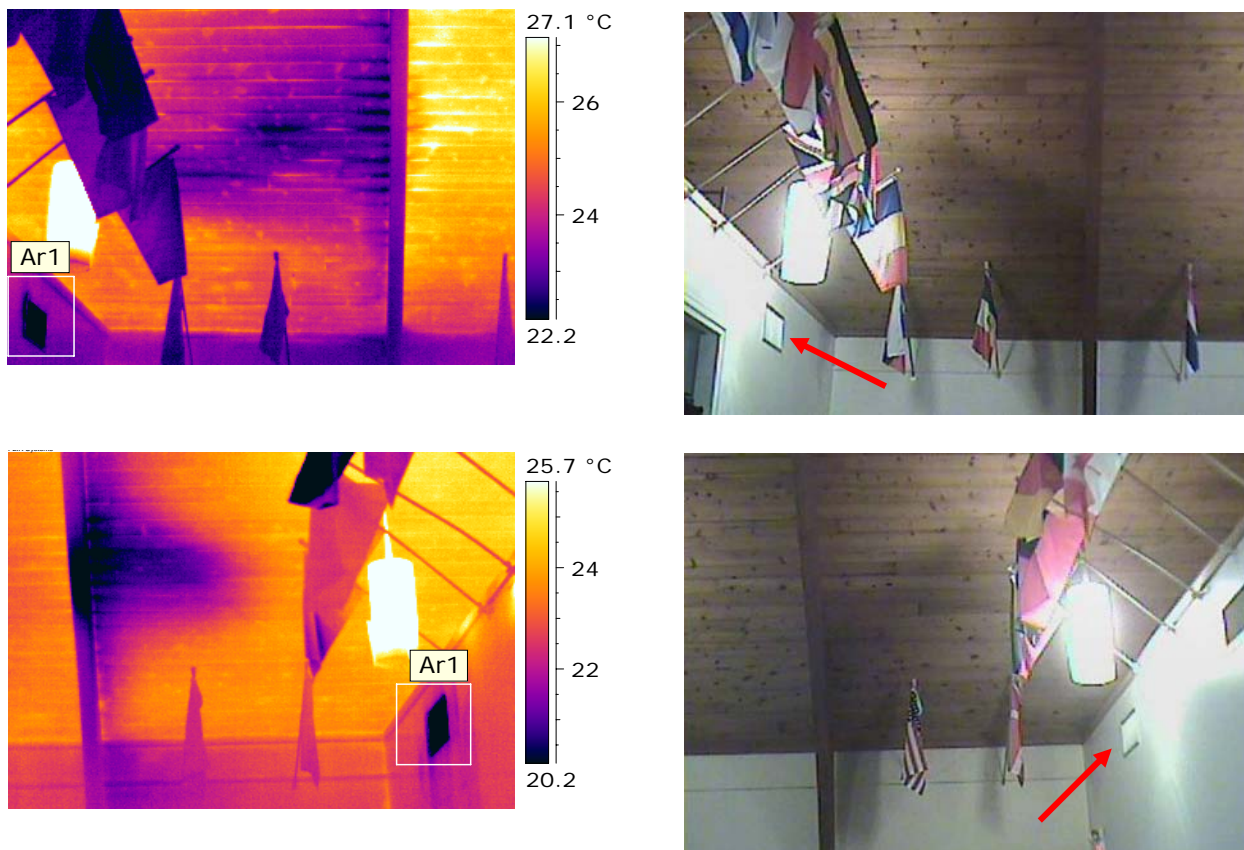
Thermogram/photo pairs in Figure 4 show where HVAC vents are directing cooling air onto the ceiling of the room and trapping it behind the structural beams. By trapping this air in this way, proper air circulation through the room is likely being impeded.

Figure 4. East Side of Sanctuary (Top). West side of Sanctuary (Bottom). Arrow indicates vents. Darker (cooler) regions on the ceiling indicate cooling by conditioned air.

Figure 4 images show the ceiling at the rear of the Sanctuary. Please note the area boxes (Ar1) in the IR images which show the HVAC vents and the red arrows in the digital pictures showing the same vents. The IR images show the difference in temperature at the ceiling on either side of the structural beams.

By redirecting the diffusers for these HVAC vents, the air flow might be directed so that is trapped less by these structural beams. This may allow for more of the air to flow through the room allowing for proper air circulation and cooling of the room.

The two diffusers have been redirected subsequent to this survey.

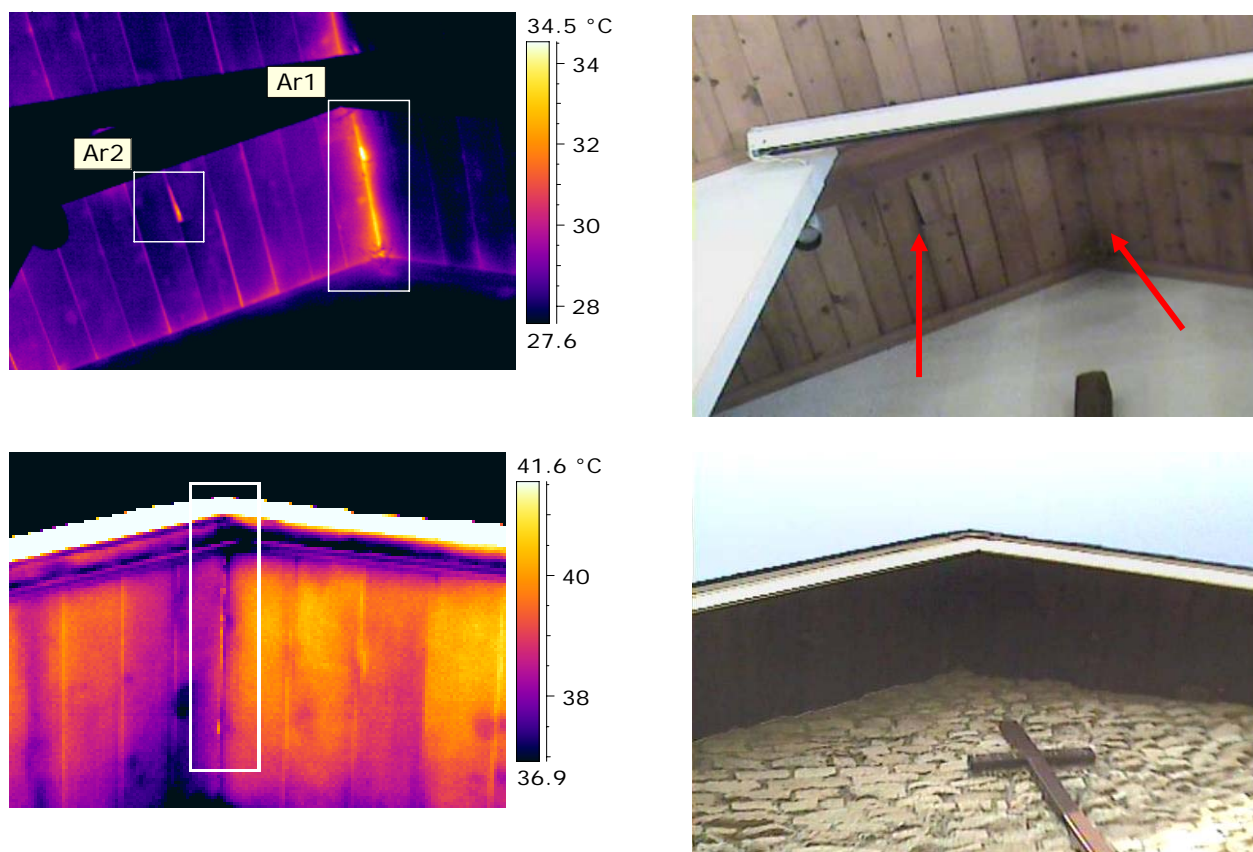
Figure 5. Interior View (Top). Exterior View (Bottom)

Figure 5 top thermogram/photo pair shows the peak of the ceiling at the south end of the Sanctuary above the baptistery (note the top of the decorative cross in the digital picture). The two area boxes in the IR image show areas where the roof deck has separated. These are areas where excessive heat is being allowed to enter the building.

Figure 5 bottom thermogram/photo pair shows the exterior view of this same peak. The boxed area in the IR image shows a continuation in the separation between the roof deck boards (shown in Box Ar1 of the Interior View) through the wall to the exterior of the building.

The remedy for this would be to reattach the separated board shown in Box Ar2 and add insulating material into the gap between boards at the peak of the ceiling shown in area Box Ar1.

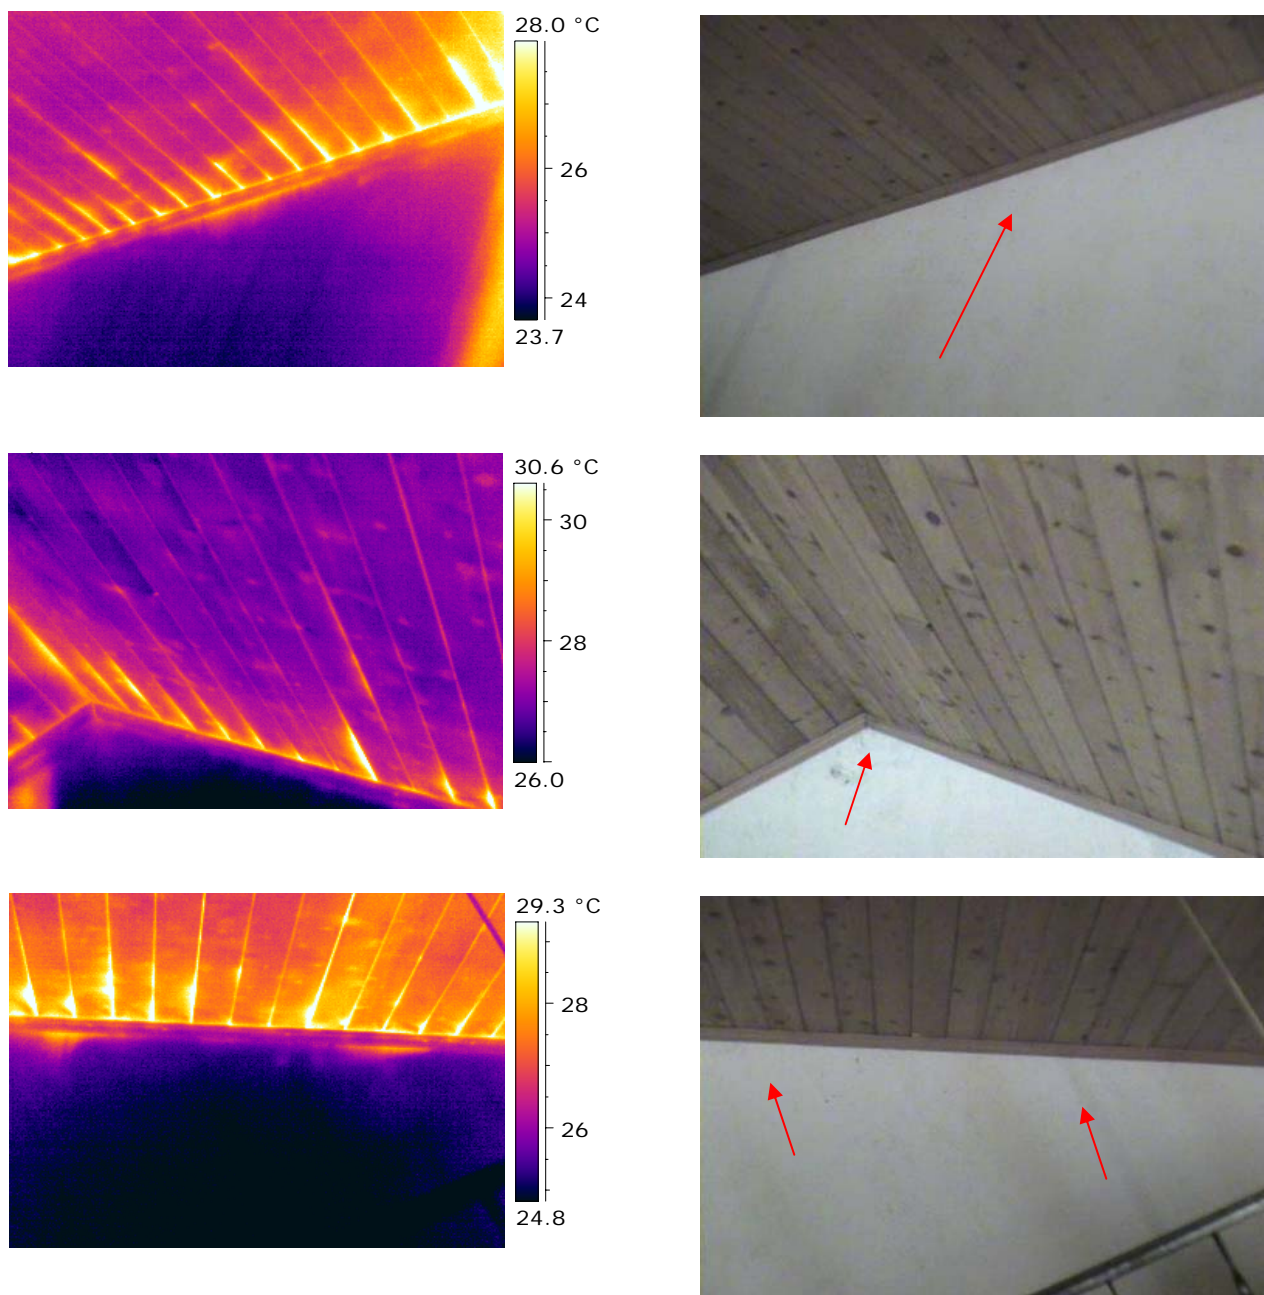
Air and heat are infiltrating past the wall/roof interface along the north Sanctuary wall. This again is the wall above the false ceiling for the Lobby. It is being partially blocked by the wood trim, but is still infiltrating past this trim. This infiltration is shown in the series of thermogram/photo pairs given in Figure 6.

Figure 6. The thermogram/photo pairs from top to bottom progress along the north wall from the west to the east.

The air infiltration can be seen by the evidence of the air flow heating up the wall below the trim. Further, the heat is infiltrating along seams between the roof deck boards.

The remedy for this condition would be to install insulating material or caulking along the roof/wall interface to stop the air movement.

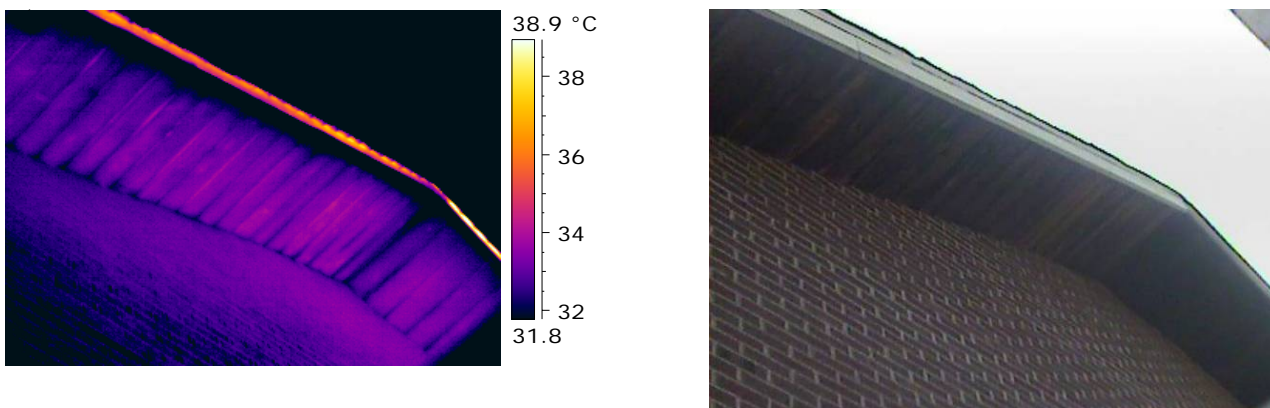
Figure 7 shows the exterior view of this same north wall under the roof overhang. The darker areas at the roof/wall interface show where the cooler air from inside the building is escaping through the seams in the roof deck boards.

Figure 7. Exterior complementary thermogram/photo pair of Figure 6 images. Here, cooler regions indicate loss of cooling air to the outside.

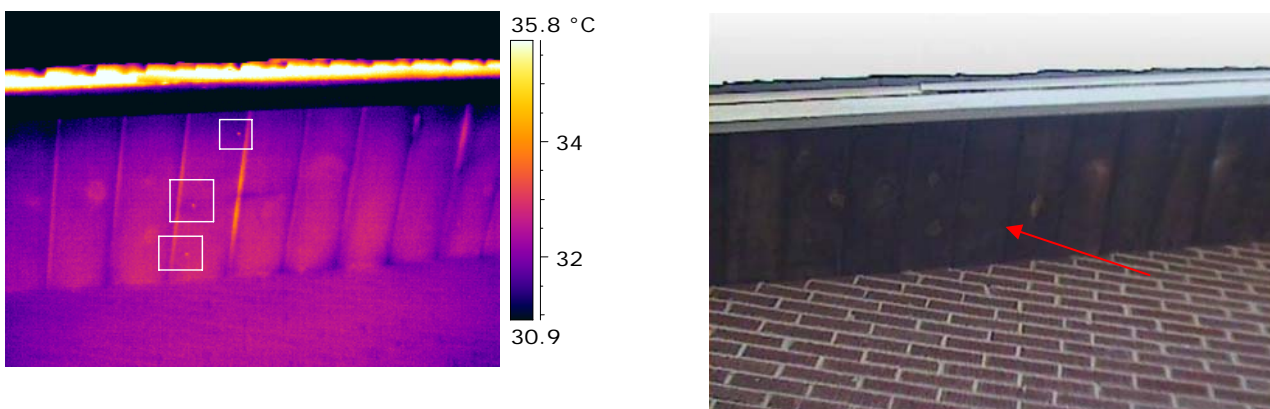
This was a finding from the IR survey that was unexpected. The thermogram/photo pair of Figure 8 shows holes in the exterior soffit boards that have been caused by carpenter bees. The pictures are of the north overhang. There are several dozen of these holes throughout the boards in this overhang, as well as the south overhang. Figure 8 is just representative of these holes.

Figure 8. Thermogram/photo pair indicating carpenter bee damage indicated by boxes in IR image and arrow in photo.

I understand that there are plans to install siding under the north and south overhangs to keep the carpenter bees from inhabiting these areas in the future. Before this is done, the roof/wall interface should be sealed to eliminate the air movement as well.

The siding has been installed under the soffit areas subsequent to this survey. Insulating foam was used to seal the wall/roof interface prior to the siding being installed.

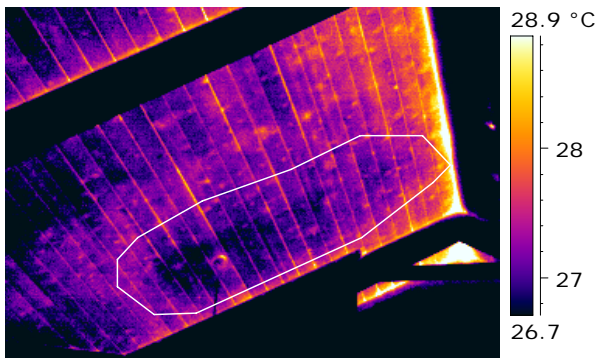
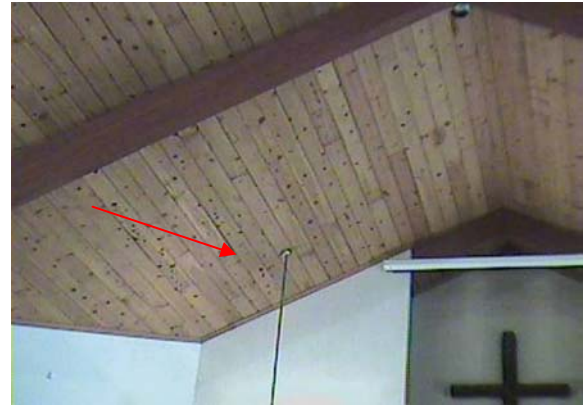
Figures 9 and 10 show evidence of water infiltration into the roof deck boards. This water infiltration was from the steeple that had already been removed from the Sanctuary roof. The areas where the water infiltrated into the roof deck shows as the darker areas of the ceiling (white outlined regions in the IR images in Figures

9 and 10). The moisture is still trapped in the roof deck boards since I was able to detect its presence. This was another unexpected finding from this survey.

Figure 9. Water intrusion shown by outlined area in IR image and indicated by arrow in photo. East side.

The trapped moisture shows as darker, or cooler, areas in the IR images since it cools as it evaporates.

No action is needed for this condition. The moisture will eventually dry out of this material as the source of the water intrusion has been removed.

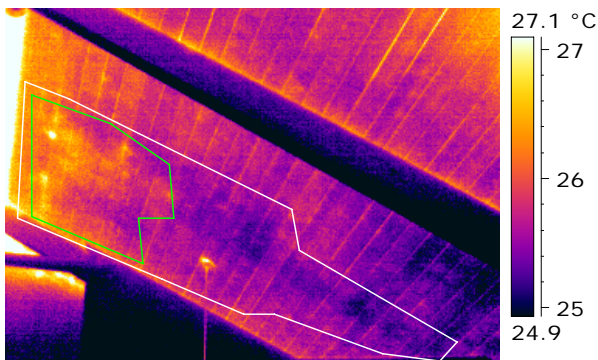
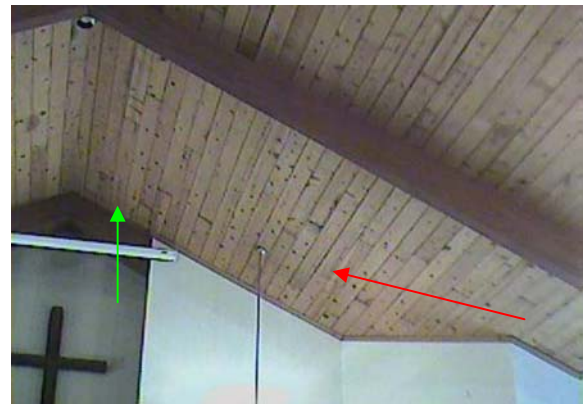
Figure 10. Water intrusion shown by outlined area in IR image and indicated by arrow in photo. West side.

The green outlined area inside the white outlined area of Figure 10 shows the bolt holes where the steeple was bolted to the roof. Due to the sun heating this side of the roof, the heat is able to conduct through the roof deck quicker through these holes and is heating up the moisture in the roof deck around these holes much faster.

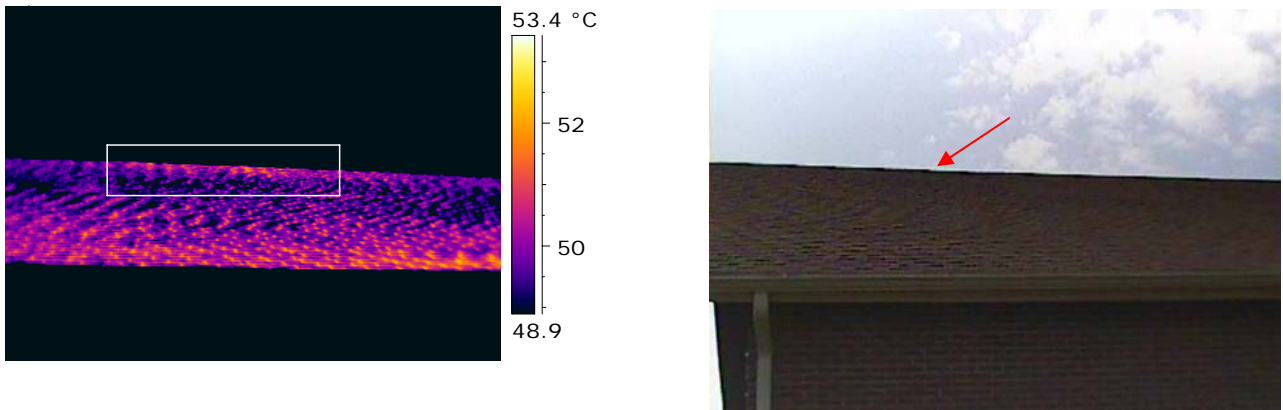
I also took pictures of the roof from the exterior showing where the steeple used to be, Figures 11 and 12. This area has been shingled over to match the rest of the roof. However, you can still see that there is trapped moisture under the roofing materials.

Figure 11. This thermogram/photo pair shows the east side of the Sanctuary roof.

The area shows warmer since the sun has moved off this side of the roof and this side has started cooling. The moisture underneath is retaining the heat longer and will show warmer than the surrounding roofing materials.

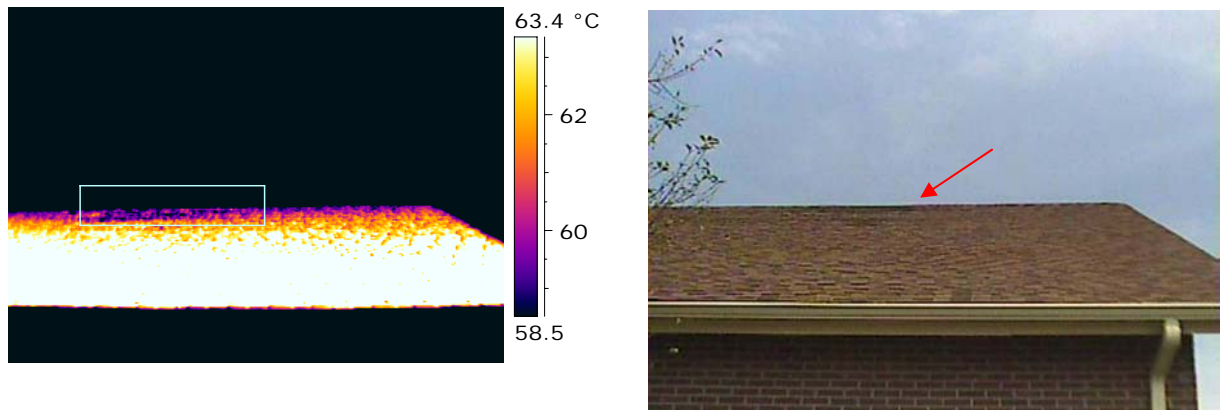
Figure 12. This thermogram/photo pair shows the west side of the Sanctuary roof.

The area shows cooler since the sun has now moved to this side of the roof and is now heating this side of the roof. The moisture underneath is taking longer to heat up than the surrounding roofing materials, thus will show cooler.
