Stucco Surveys Using Infrared Thermography

Robert Scherer
Infrared Consultants

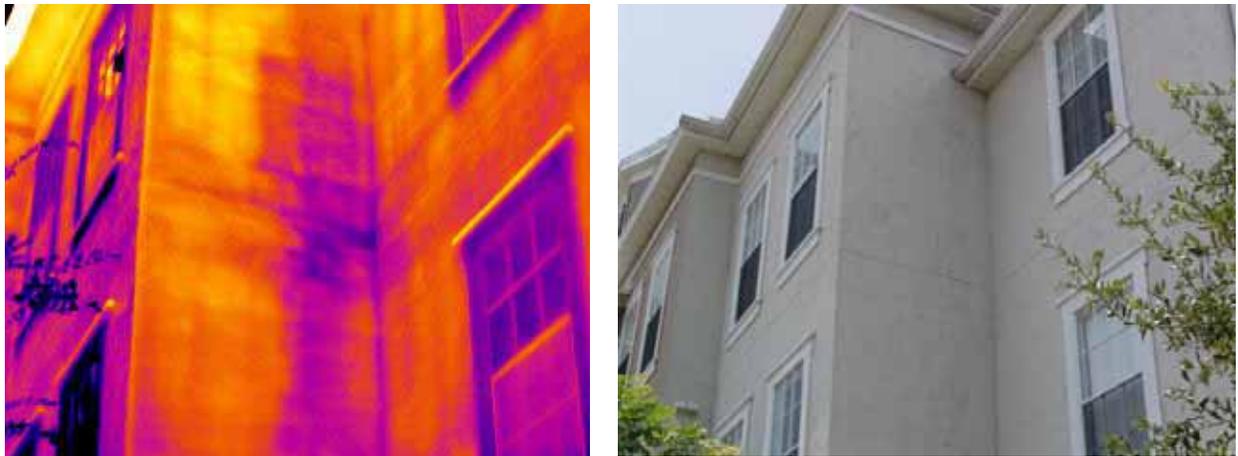
Figure 1. Thermogram/photo showing damaged sheathing behind stucco system

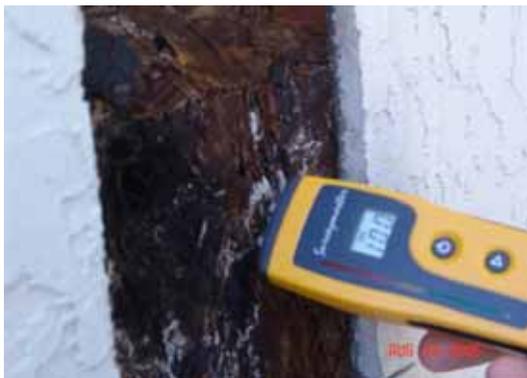
Figure 2. Test cut determined 100% moisture readings using hand held moisture meter.

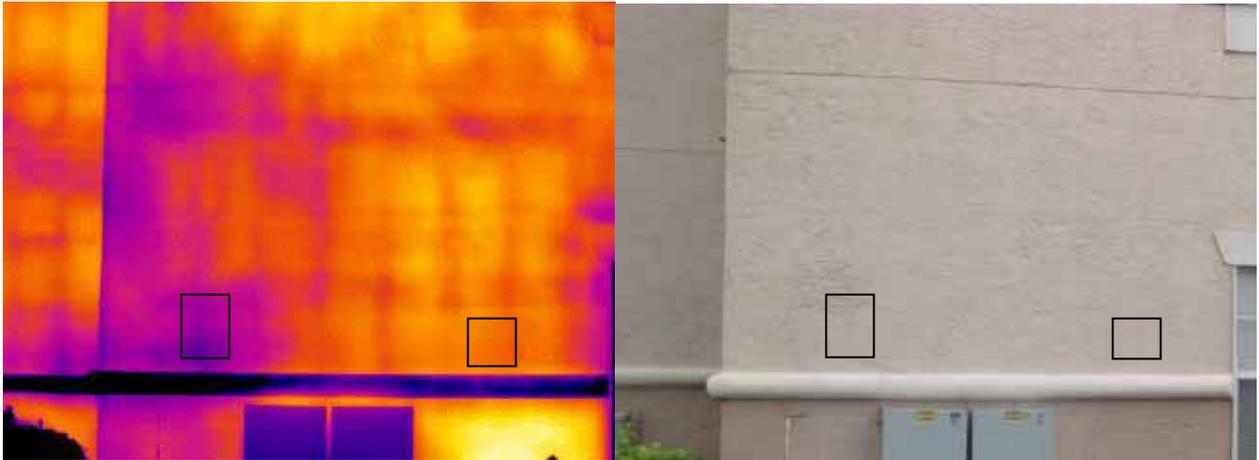
Figure 3. Thermogram/photo showing damaged sheathing behind stucco system

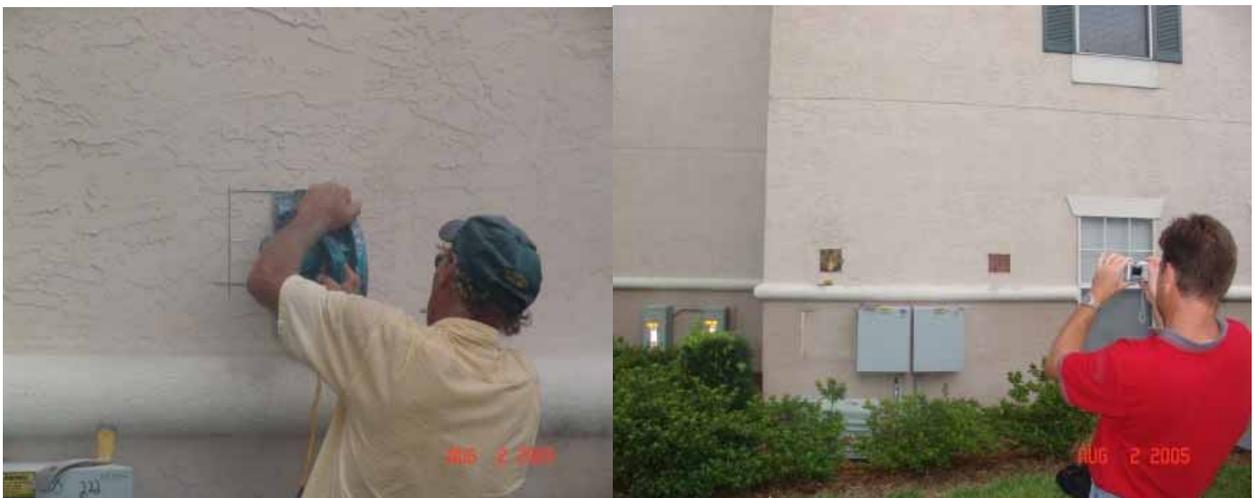
Figure 4. Test cuts are performed to determine a baseline for interpretation

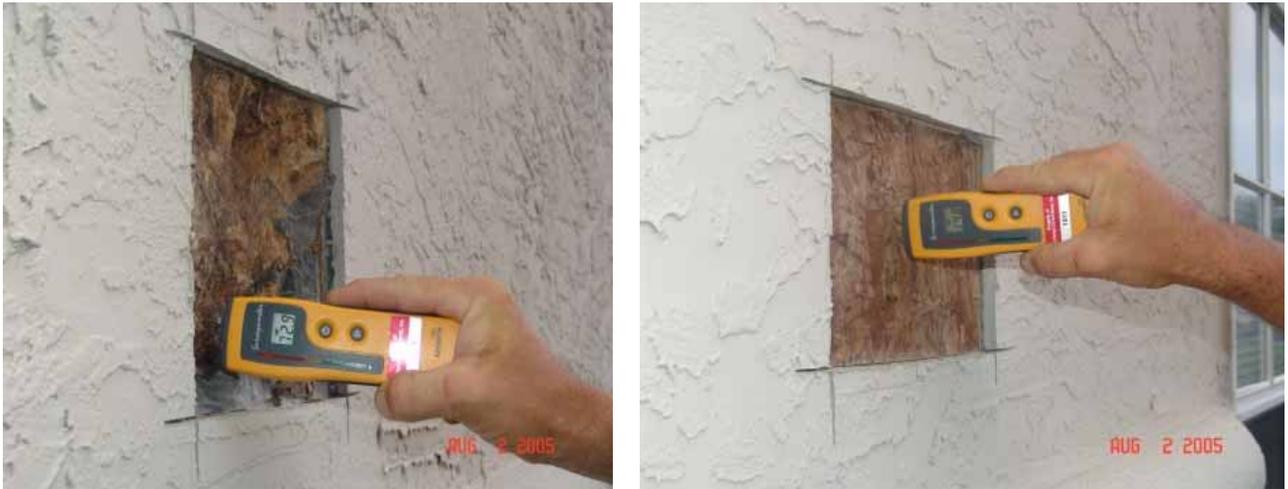
Figure 5. Moisture readings are then taken to confirm IR findings; left photo has 72.9% moisture, right photo has 14.8%

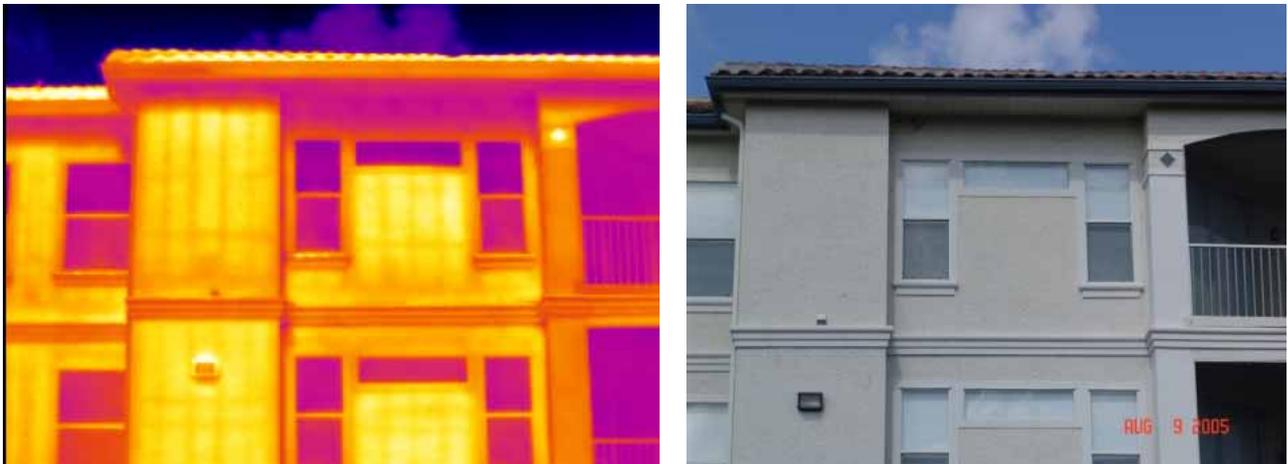
Figure 6. Thermogram/photo showing no anomalies

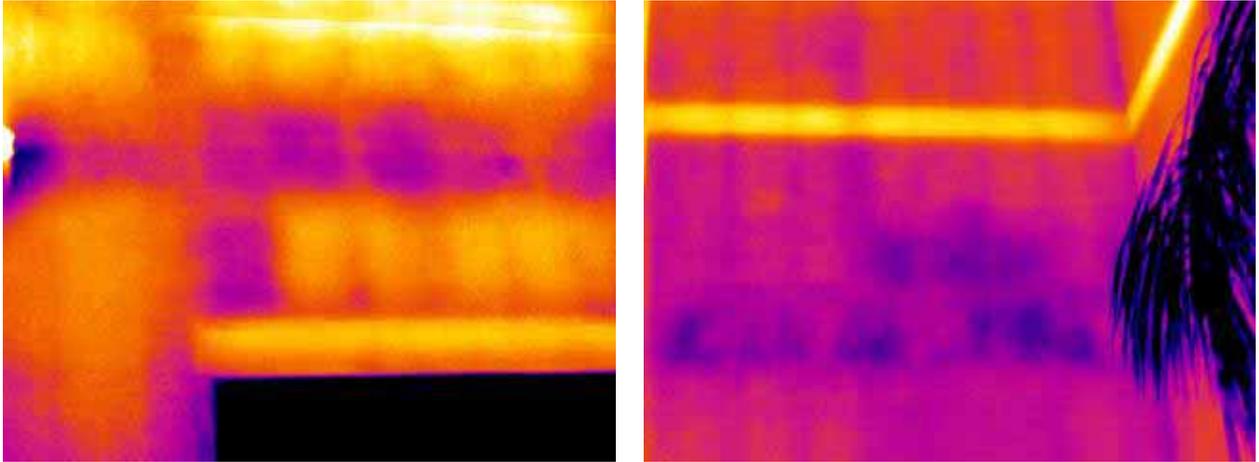
Many building conditions can also cause false readings. Multi-story wood framing buildings will have 12 to 24 inch floor joists in between each floor. AC ducts, plumbing, and other systems are located in this space. Leaking air ducts can sub-cool the space and will show up as possible moisture in the exterior cladding. (see example below) We generally discount these areas unless the delta-T is extreme.

Figure 7. Images of false readings
