Infrared Inspection on Electrical Installations at Hospitals

Mohd Azmi Mohd Dani
Faber Medi-Serve Sdn Bhd

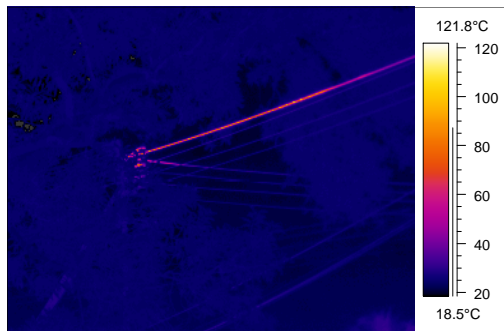
Overhead lines: Insulation deteriorated

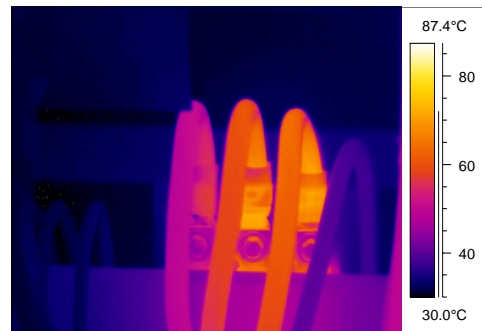
Main Switchboard: Unbalanced load

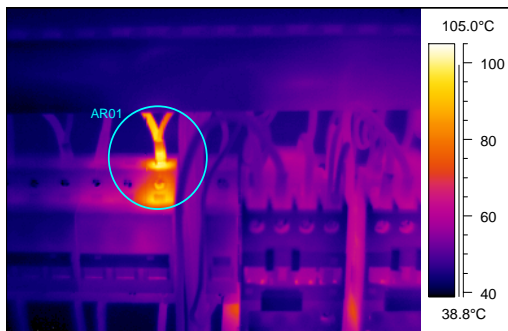
Distribution Board: Loose cable connection

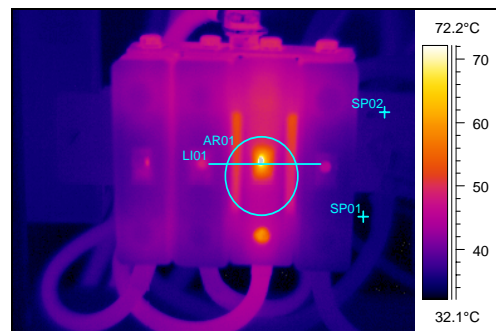
Distribution Board: Overload at Fuse

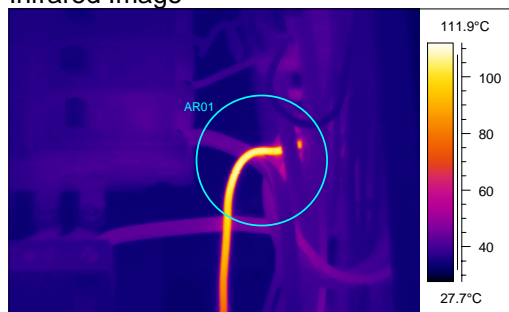
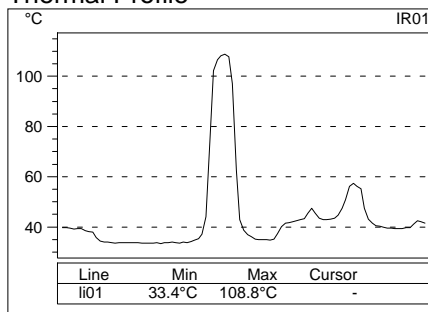
Figure 2: Pre-repairs: loose connection creates excessive heat on cable end, thus producing a spike in the thermal pattern

The infrared image and thermal profile in Figure 2 shows a hot spot (at temperature 108.8 deg Celsius) on a cable connection at the distribution board. The overheating was caused by a loose or improper cable connection.

After corrective measures have been executed, the infrared image (Figure 3) shows no hot spots and the thermal profile shows the normal operating temperature under working conditions.

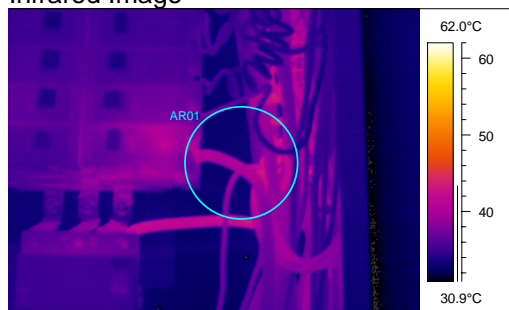
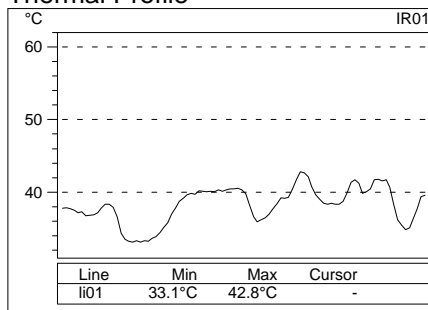
Figure 3: Post-repairs: The thermal pattern is uniform

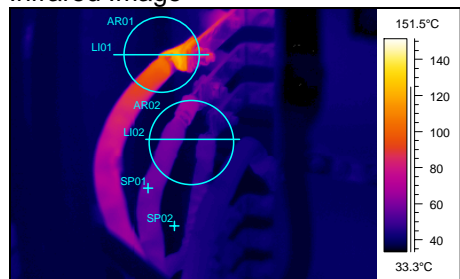
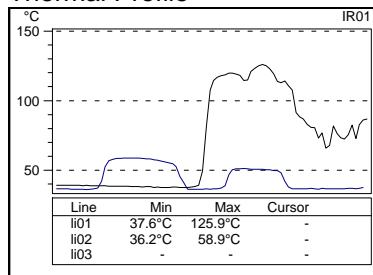
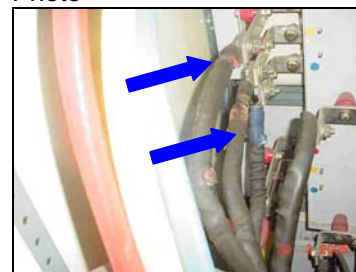
The infrared image and thermal profile below (Figure 4) shows hot spot (at temperature 125.9 deg Celsius) on the cable connection at the main switchboard. The overheating was caused due to deteriorated cable insulation. Arrows show where the red and yellow phase cable insulation has deteriorated.

Figure 4: Pre-repairs: High temperatures on cable were detected. Cable heated due to deteriorated insulation at the main switchboard

After repairs to the cable, the infrared image reveals no hot spots and the thermal profile shows normal operating temperatures under working conditions.

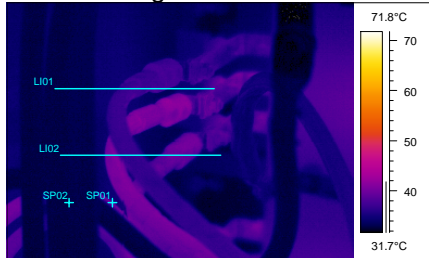
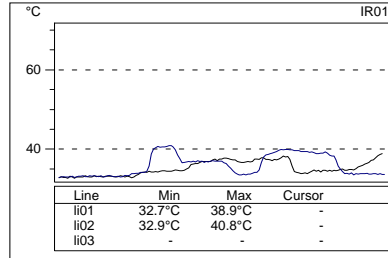
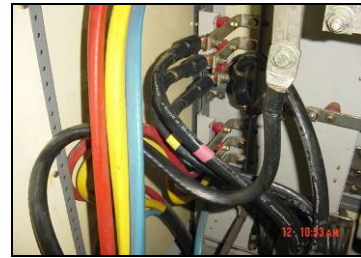
Figure 5: Post-repairs: The thermal pattern is uniform

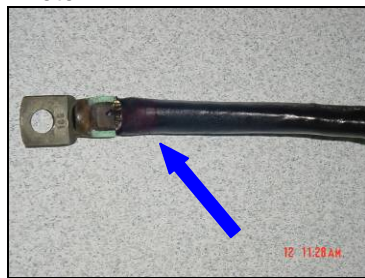
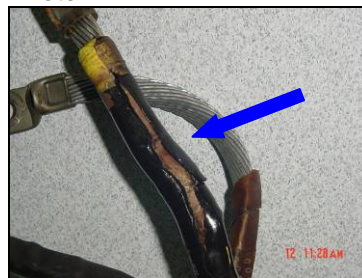
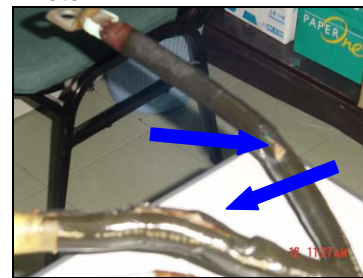
Figure 6: Photos show the damaged cable after installation of a new one
