Thermographic Building Inspection

SAMPLE

Infrared Solutions Ltd

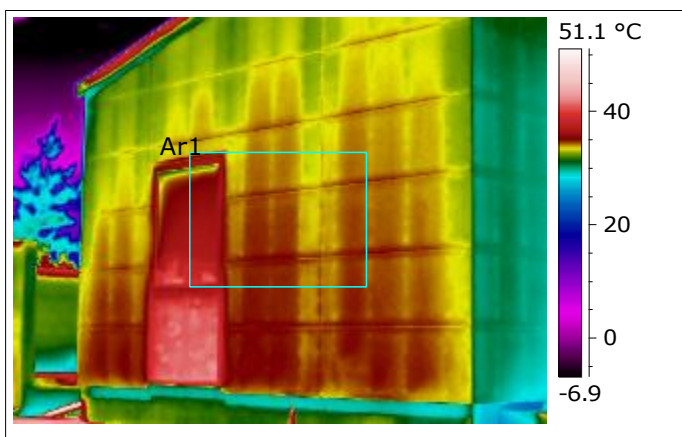
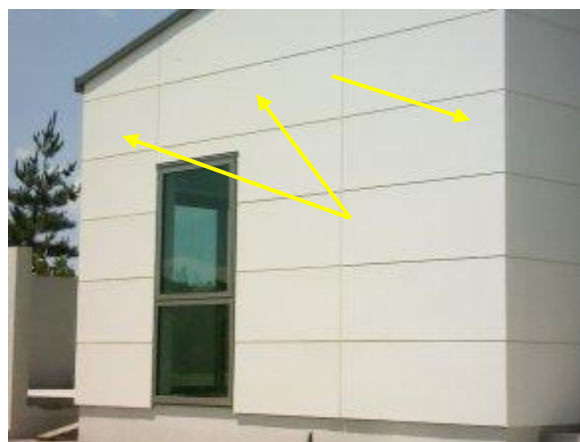
Comment: Possible insulation issues.

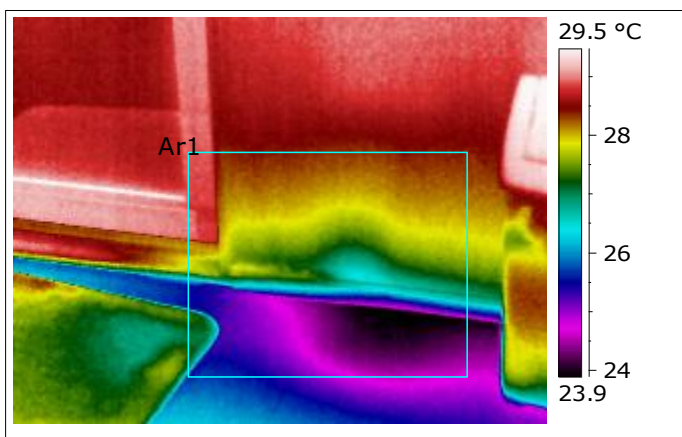
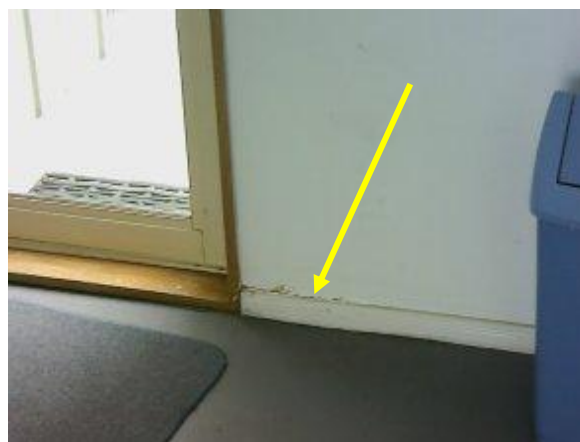
Date	17/12/2012	Client	Sample
Image Time	5:06:22 p.m.	Location	
Image Camera Type	FLIR T640	Floor	Ground floor
Emissivity	0.90	Room	Garage
Object Distance	1.0 m	Area within room	Wall / floor
Reflected Apparent Temperature	22.0 °C	Deviation	Moisture
Atmospheric Temperature	20.0 °C	Baseline moisture meter readings	10 to 20
Ar1 Max. Temperature	29.1 °C	Anomaly moisture meter readings	70 to 80

Comment: Infrared anomaly seen in this image was investigated further with a Trotec T2000s moisture meter and readings were found to be high.

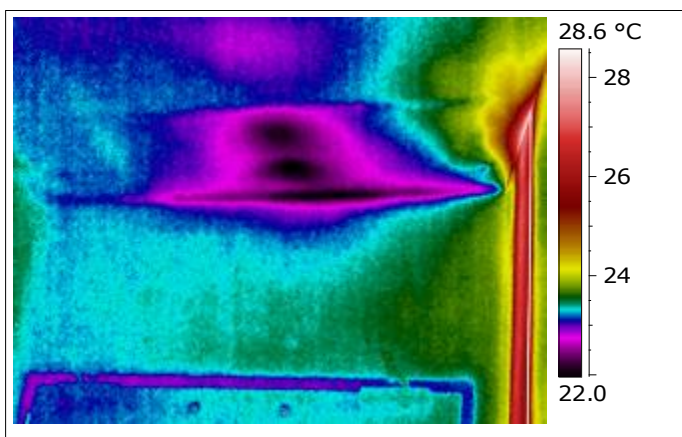
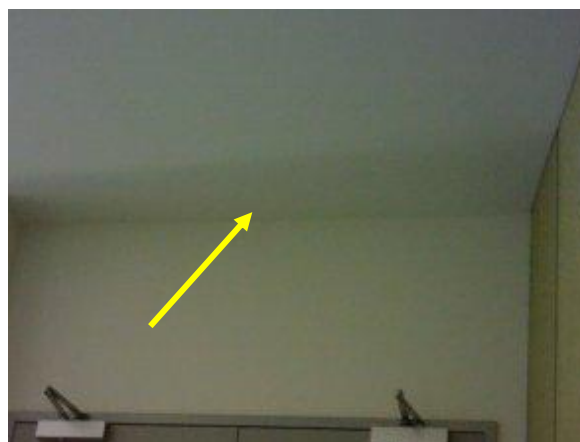
Comment: Waterleak, unseen from a normal visual inspection.

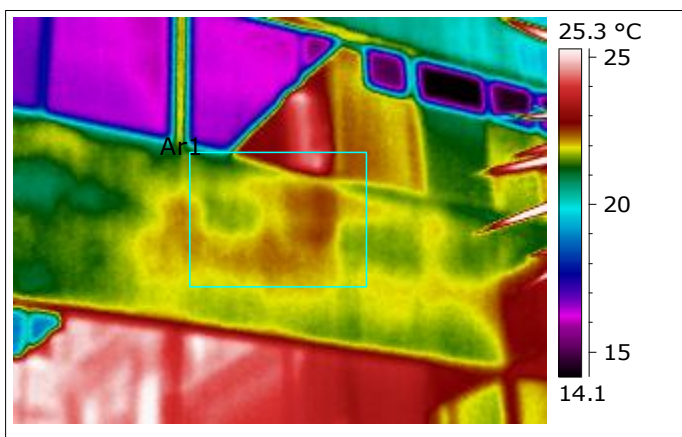
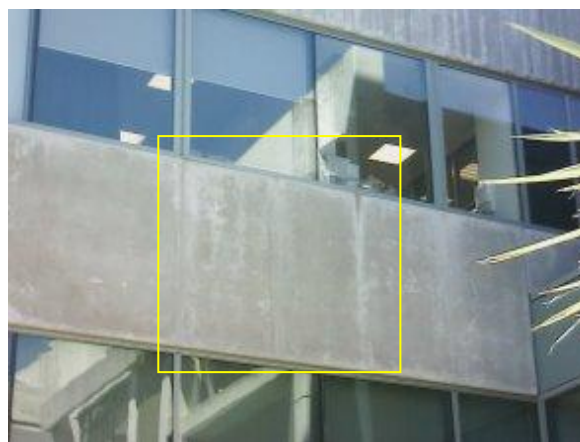
Comment: Possible water leak

Recommendation: Investigate further to determine the severity of the problem.

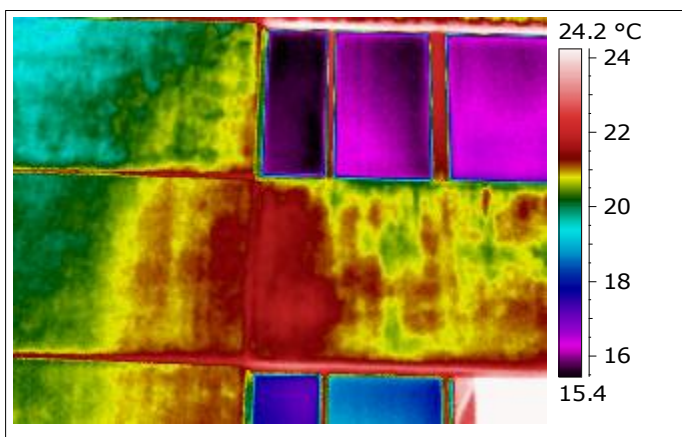
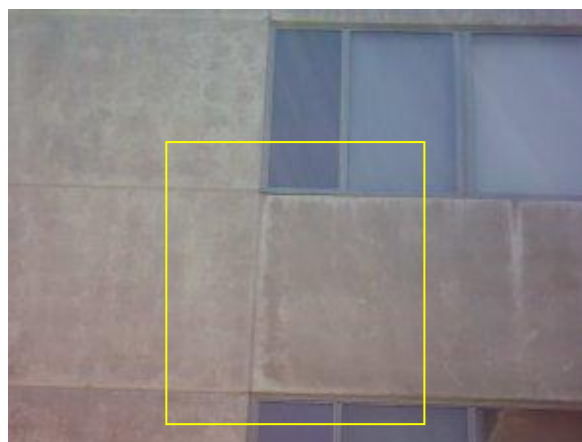
Comment: Possible water leak

Recommendation: Investigate further to determine the severity of the problem.

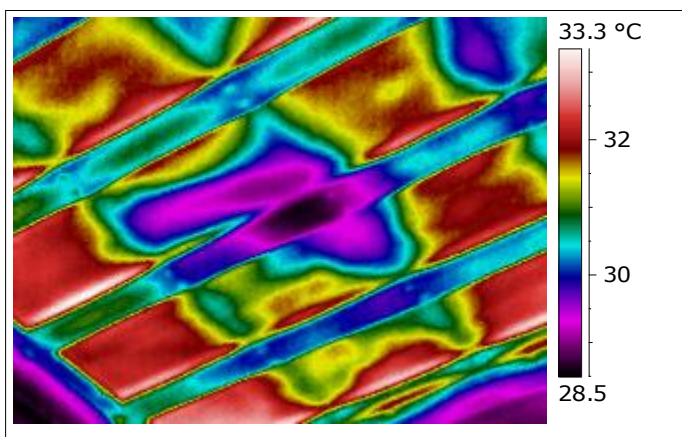
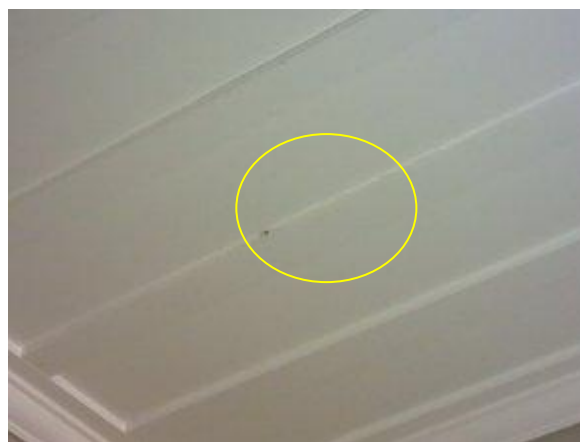
Comment: Waterleak, unseen by a visual inspection.

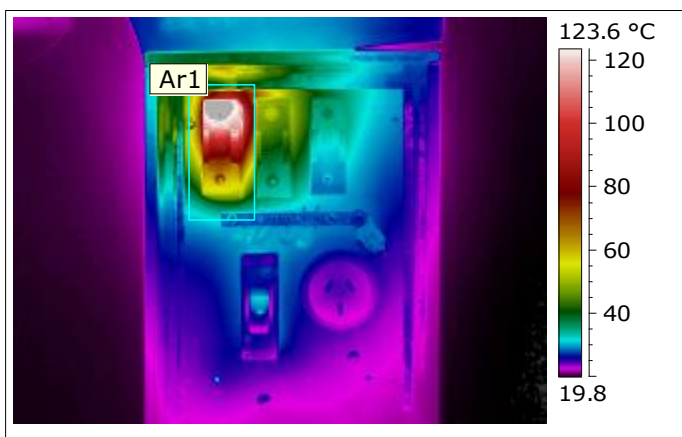
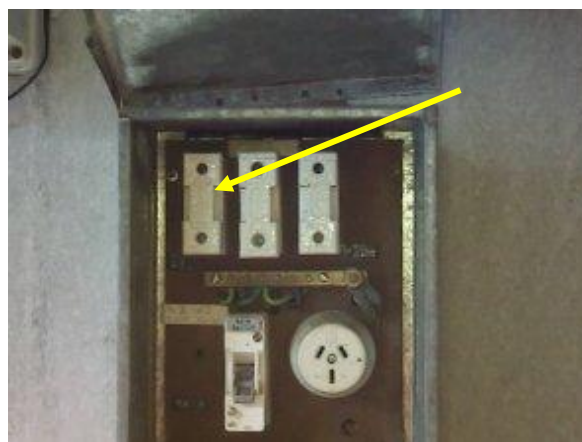
Object Distance	1.0 m																				
Atmospheric Temperature	20.0 °C																				
Ar1 Max. Temperature	>160.2 °C																				
Location	Sample																				
Equipment	Distribution board																				
Area	Interior wall

Comment: A unknown severe electrical fault found, this would have caused a fire in a very short amount of time.

Recommendation: Inspection was stopped and electrician immediately dealt with the problem.
