## Using Infrared Thermography as an Added Diagnostic Tool in Building Inspections

Roy Chan

Consumers Choice Property Consultants Inc.

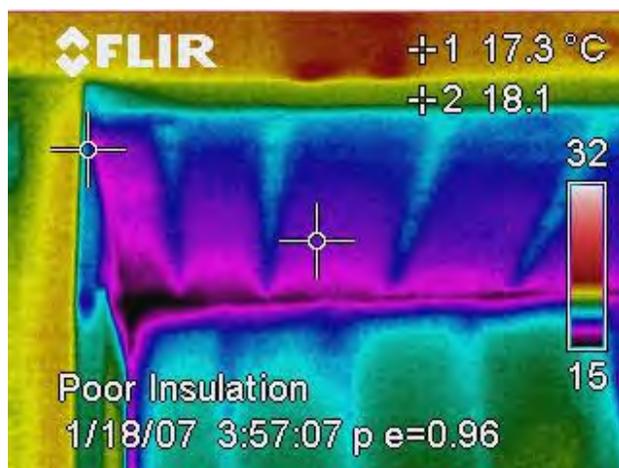
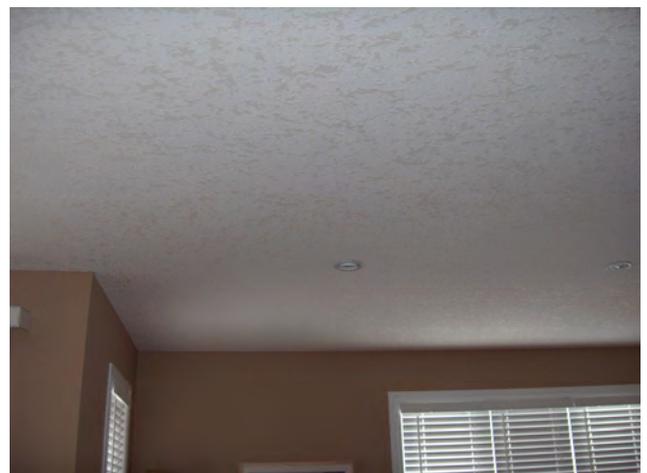
Figure 1 is an IR image of missing insulation on the ceiling below an open balcony in a brand new house. The owner was perplexed by why it was so drafty sitting on the couch by the exterior wall until we showed up with the IR camera and demonstrated the insufficient insulation in the ceiling space which created the air leakage. In fact, this design was the owner's idea in the first place – back to the drawing board!

Figure 1. Thermogram and photo pair showing missing insulation on the ceiling below an open balcony.

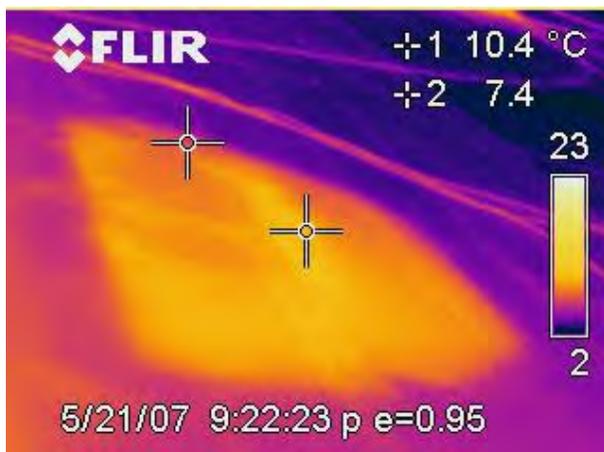
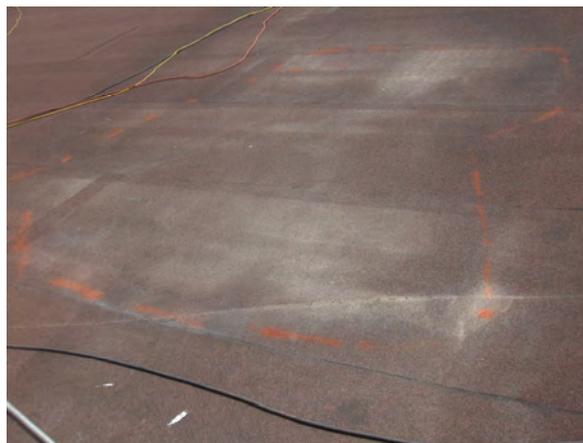
Figure 2 shows the IR image of the wet insulation under the single-ply flat roof which has premature leaks. The owner has a hard time finding the leaks until we showed up with our IR camera and found all the hot spots on the roof. Now, all they have to do is fix the marked areas.

Figure 2. Thermogram and photo pair showing moisture embedded insulation on a single ply flat roof.

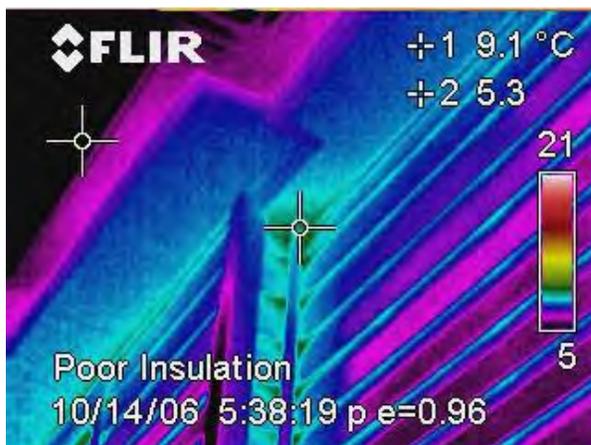
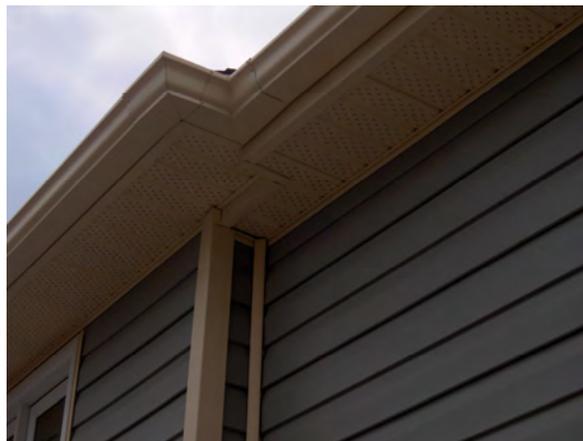
Figure 3 shows the IR image of the warm air coming out of the corner of the house during an inspection. IR thermography can be applied to perform an energy audit.

Figure 3. Thermogram and photo pair showing air leakage in a house inspection.

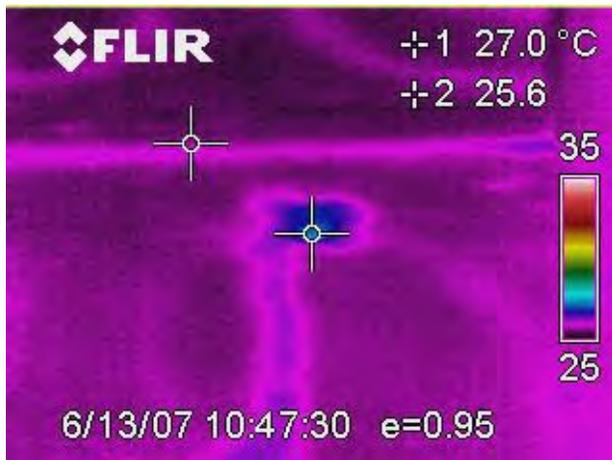
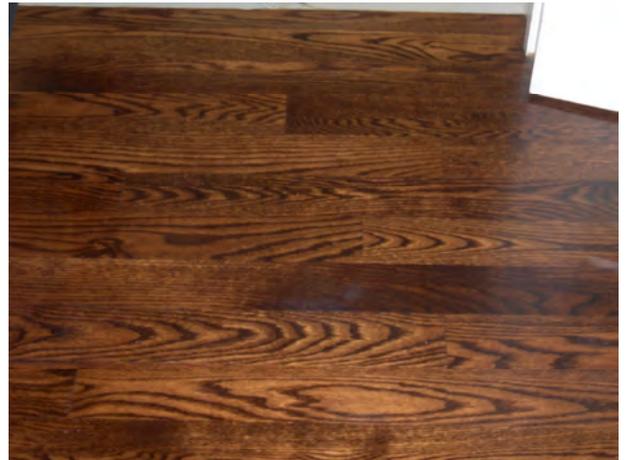
Figure 4 shows the IR image of the water leak in a radiant floor heating pipe. Our service saves the owner from taking out all the flooring in order to find the leak. We can apply the IR camera and pinpoint the location to verify it.

Figure 4. Thermogram and photo pair showing broken pipe in the radiant floor heating system.

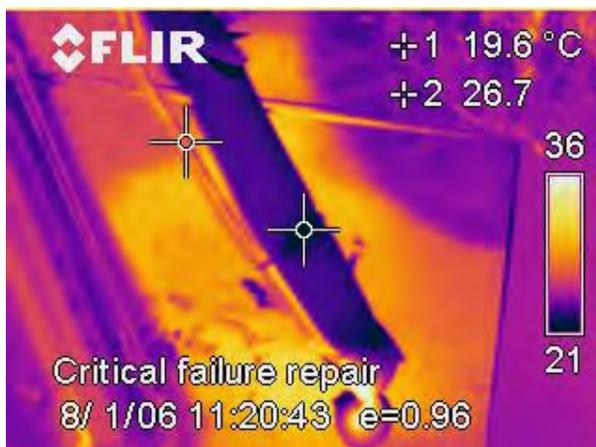
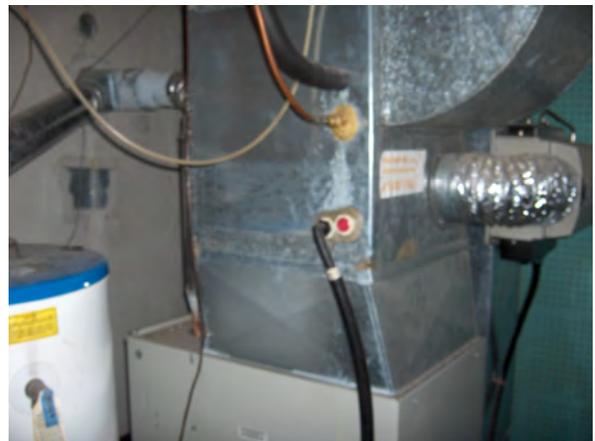
Figure 5 shows the IR image of the non-performing brand new A/C system during an inspection. The owner has been finding puddles of water on tile and basement floors, and the relative humidity shot up after a new A/C system was installed. After a series of test by elimination, we finally determined that the problem was the non-performing A/C unit. The contractor has to return to fix it.

Figure 5. Thermogram and photo pair showing inefficient new A/C system.

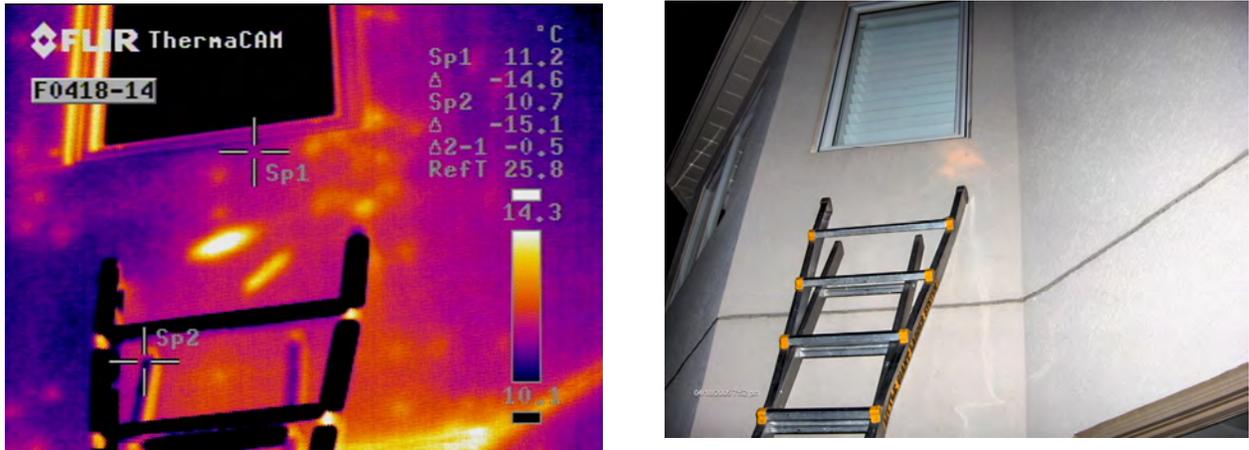
Figure 6 shows the IR image of moisture inside the stucco wall. The house was only six year old and from day one there were bubbles and patches. The builder has to return every year to patch the bubbles and within 6 years there were 50 or more patches. Finally, the owner decided to hire us to scan on all the EIFS walls and take up with the builder.

Figure 6. Thermogram and photo pair showing moisture inside the EIFS cladding.

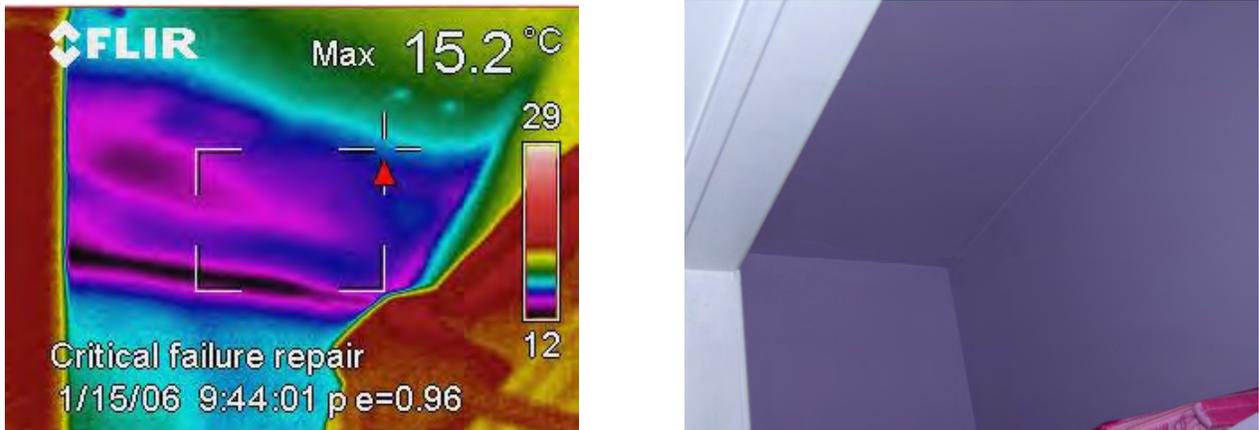
Figure 7 shows the IR image of the missing insulation inside the ceiling of a bedroom. The house has just been restored by a contractor after the house experienced a fire. Most of the second floor has rebuilt. After the restoration, my client moved back into the house and found the bedrooms to be very drafty and called us to investigate. We scanned the entire second floor and found almost every room experienced poor insulation and finally the insurance company agreed to allow my client to re-do the work again after taking out the previous inferior work.

Figure 7. Thermogram and photo pair showing missing insulation in the ceiling.
