# SAMPLE BUILDING REPORT.

## Report Information

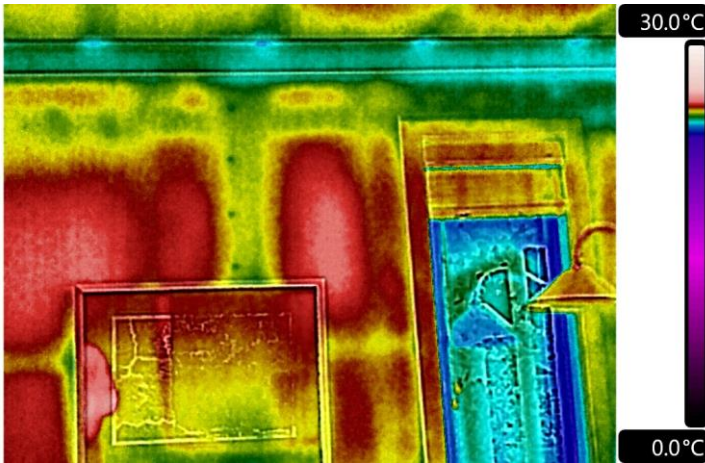
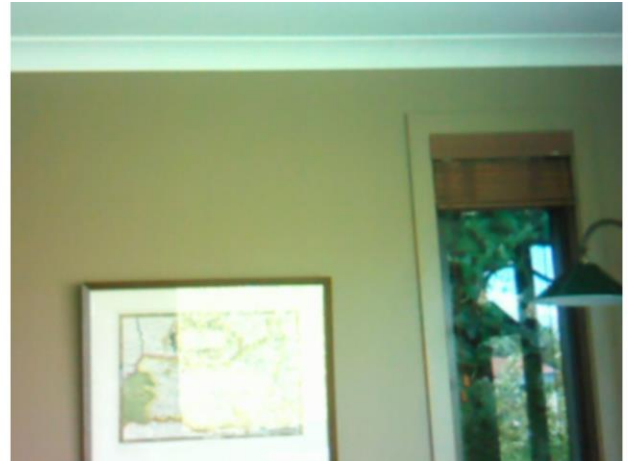
IR\_24218.jpg | 24-Jan-20 | 11:36 AM

No infrared anomaly was seen in this image at the time of inspection.

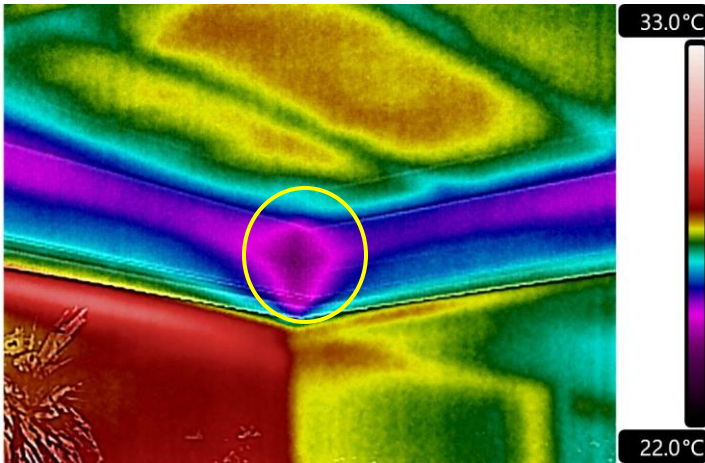
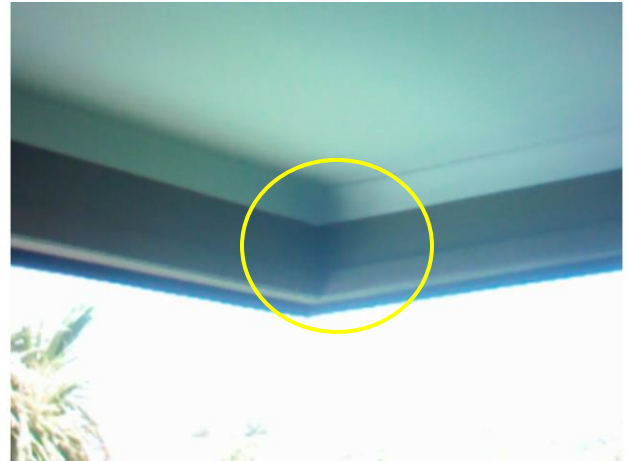
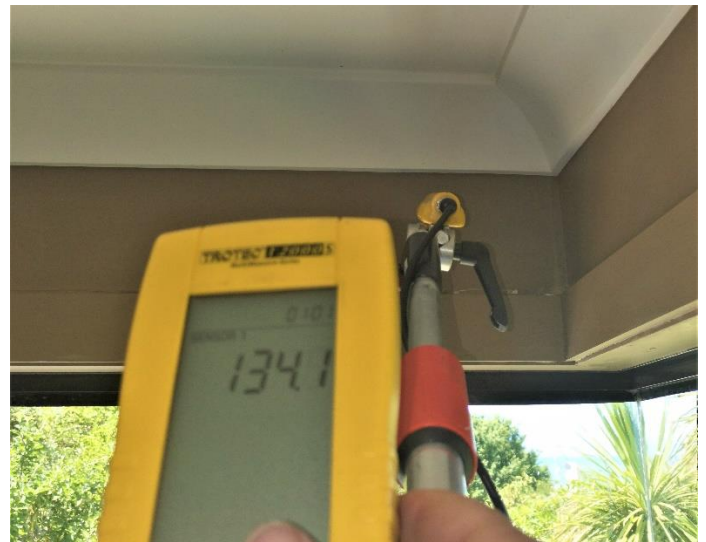
IR\_24214.jpg | 24-Jan-20 | 11:35 AM

An infrared anomaly was seen in this image, it was investigated further with a Trotec moisture meter.

Readings were found to be much higher than the rest of the area, suggesting that this anomaly is caused by a moisture issue at the time of inspection.

A possible cause of this anomaly is exterior window flashing or guttering.

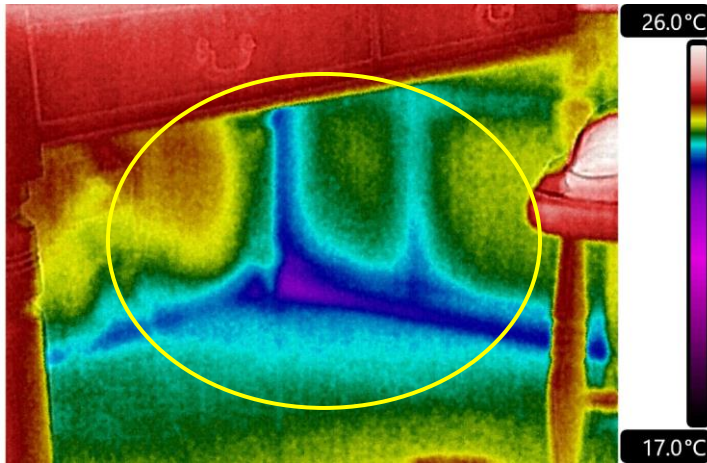
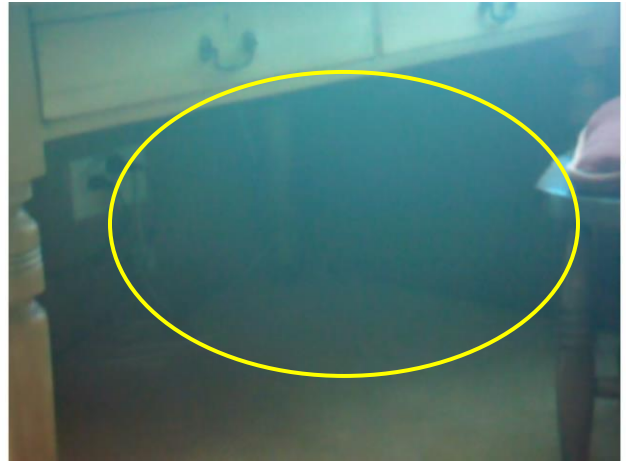
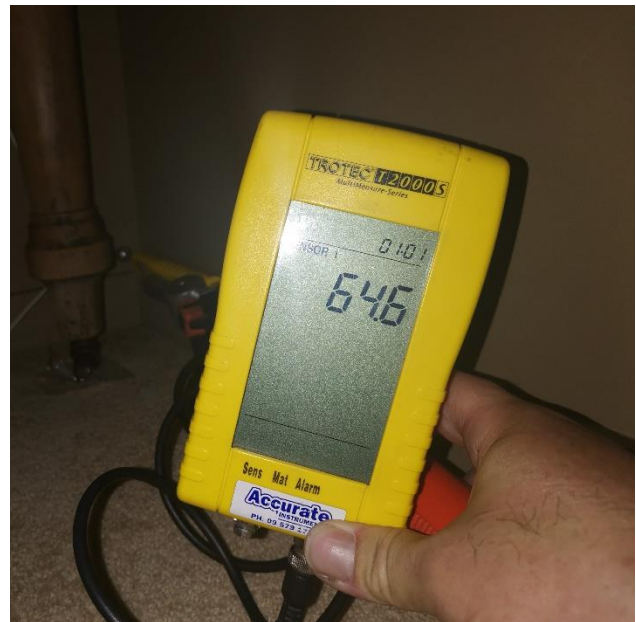
IR\_24215.jpg | 24-Jan-20 | 11:35 AM

An infrared anomaly was seen in this image, it was investigated further with a Trotec moisture meter.

Readings were found to be higher than the rest of the area, suggesting that this anomaly may be caused by a moisture issue at the time of inspection.

A possible cause of this anomaly is exterior window flashing.

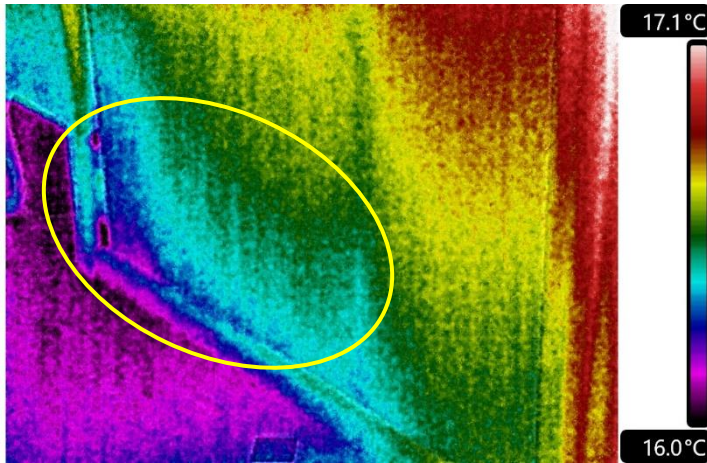
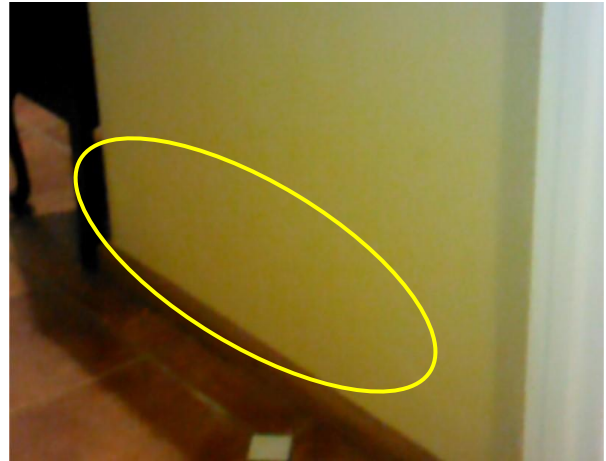
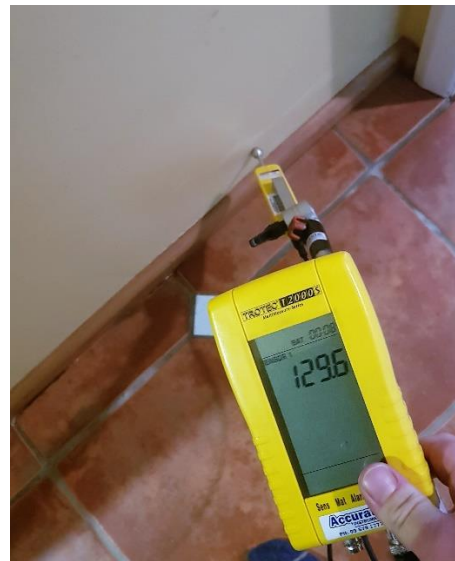
IR\_17004.jpg | 23-Nov-18 | 9:25 AM

An infrared anomaly was seen in this image, it was investigated further with a Trotec moisture meter.

Readings were found to be much higher than the rest of the area, suggesting that this anomaly is caused by a moisture issue at the time of inspection.

A possible cause of this anomaly is a leak in the shower membrane on the other side of this wall.

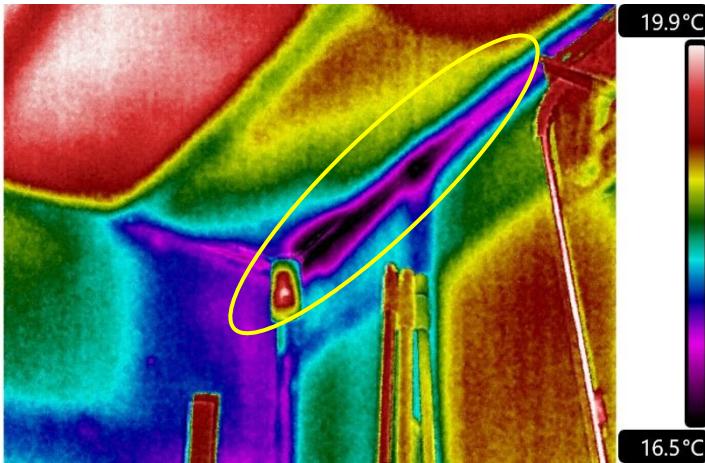
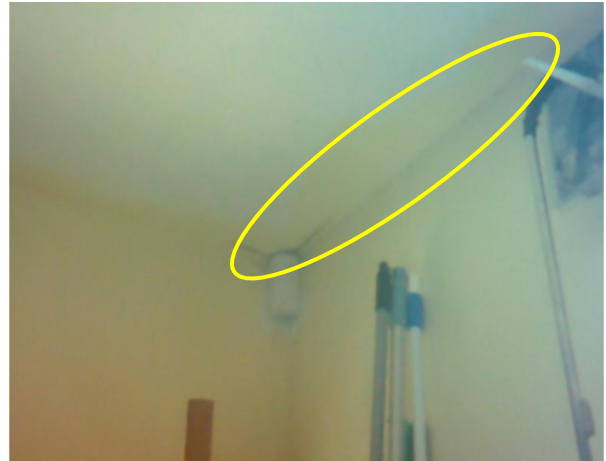
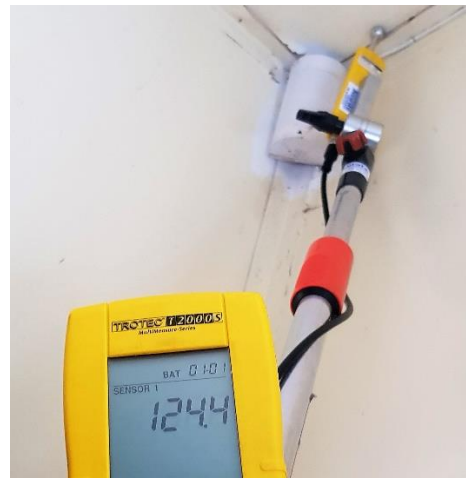
An infrared anomaly was seen in this image, it was investigated further with a Trotec moisture meter.

Readings were found to be much higher than the rest of the area, suggesting that this anomaly is caused by a moisture issue at the time of inspection.

A possible cause of this anomaly is the guttering on the roof.

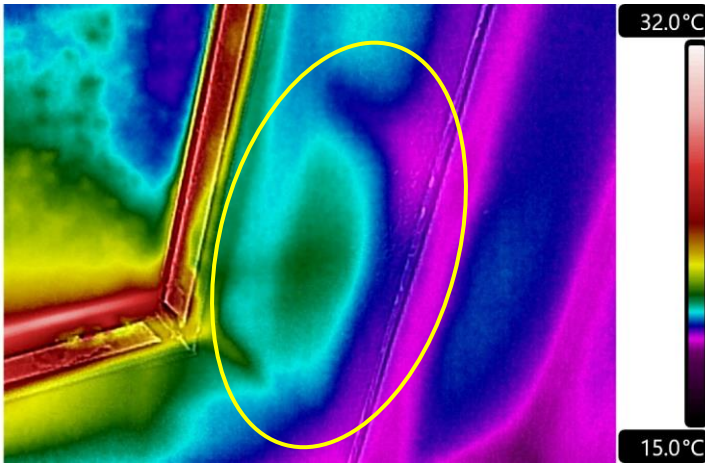
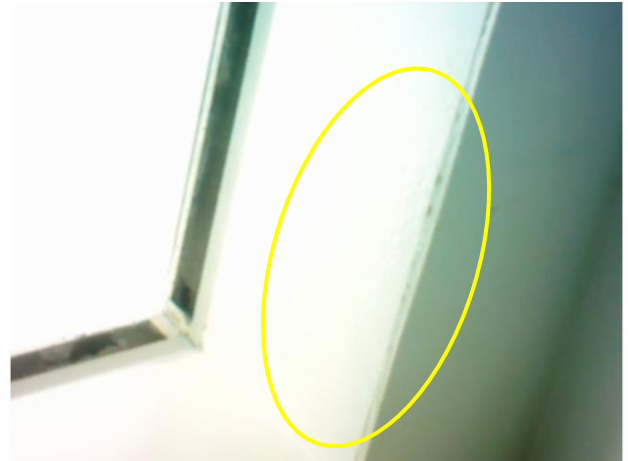
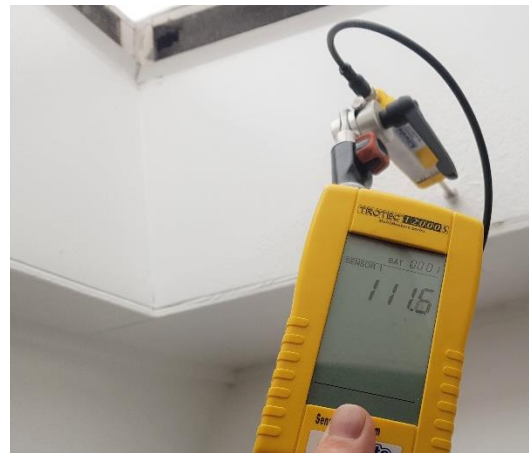
IR\_22959.jpg | 01-Nov-19 | 2:35 PM

An infrared anomaly was seen in this image, it was investigated further with a Trotec moisture meter.

Readings were found to be much higher than the rest of the area, suggesting that this anomaly is caused by a moisture issue at the time of inspection.

A possible cause of this anomaly is exterior window flashing.

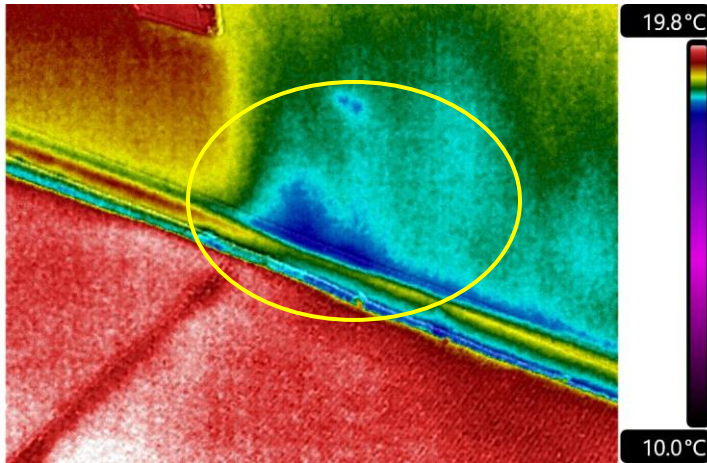
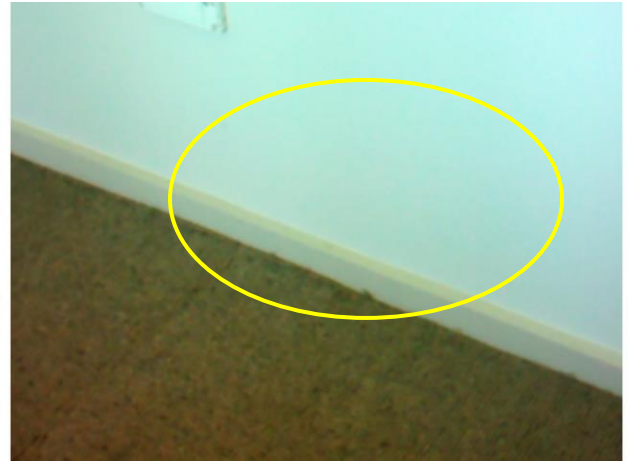
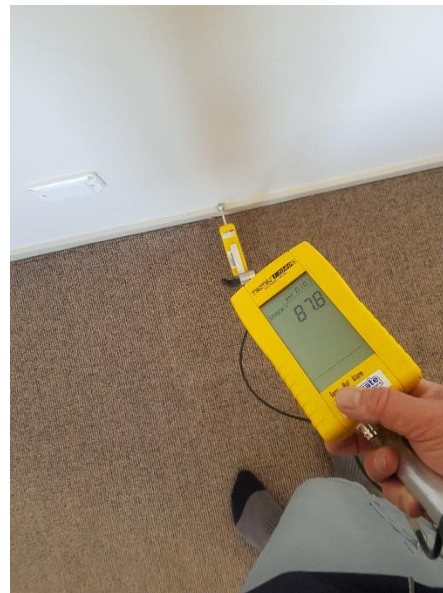
IR\_22932.jpg | 30-Oct-19 | 10:28 AM

An infrared anomaly was seen in this image, it was investigated further with a Trotec moisture meter.

Readings were found to be higher than the rest of the area, suggesting that this anomaly may be caused by a moisture issue at the time of inspection.

A possible cause of this anomaly a plumbing leak from the bathroom in the next room.

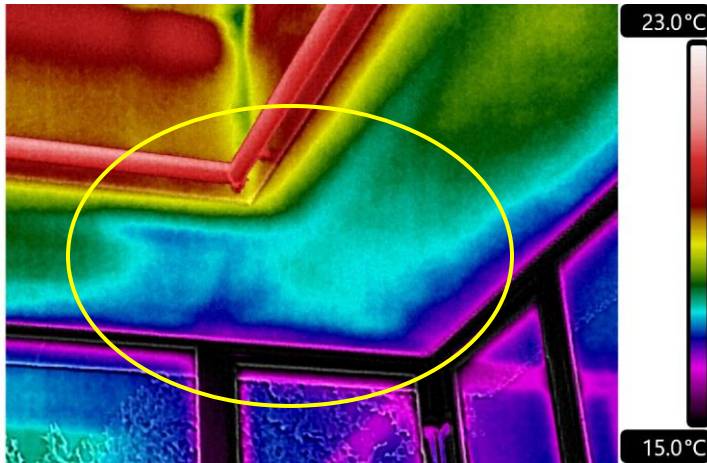
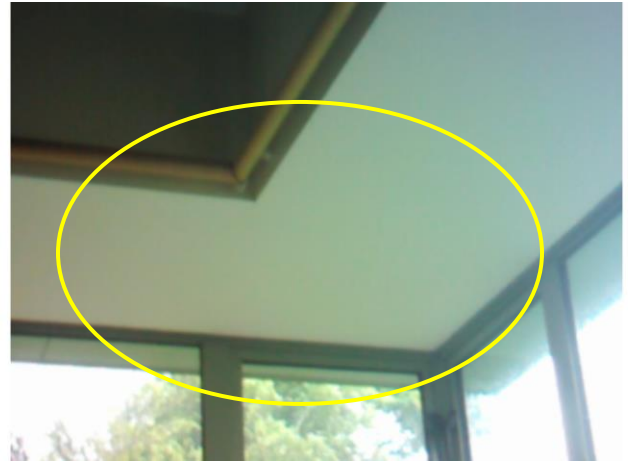
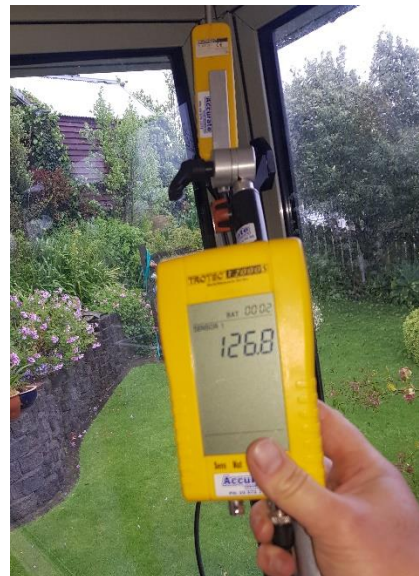
IR\_22770.jpg | 15-Oct-19 | 12:28 PM

An infrared anomaly was seen in this image, it was investigated further with a Trotec moisture meter.

Readings were found to be much higher than the rest of the area, suggesting that this anomaly is caused by a moisture issue at the time of inspection.

A possible cause of this anomaly is exterior window flashing.

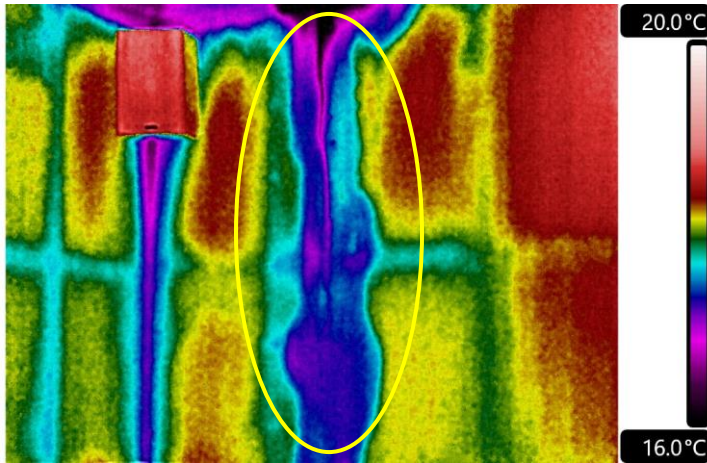
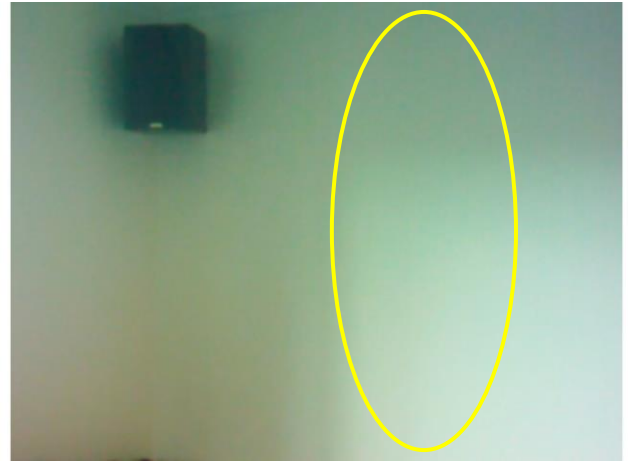
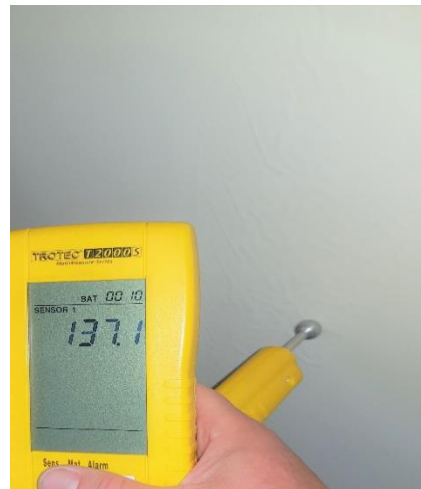
IR\_22777.jpg | 15-Oct-19 | 12:33 PM

An infrared anomaly was seen in this image, it was investigated further with a Trotec moisture meter.

Readings were found to be much higher than the rest of the area, suggesting that this anomaly is caused by a moisture issue at the time of inspection.

A possible cause of this anomaly is the guttering above.
