**Thermographic Inspection at:  
Sample**

**Inspection Date:  
2013**

**Thermographer:  
Aaron Bryant**

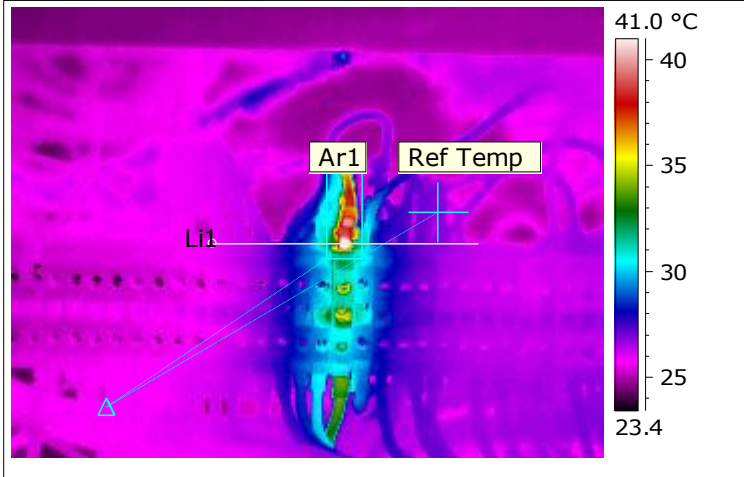
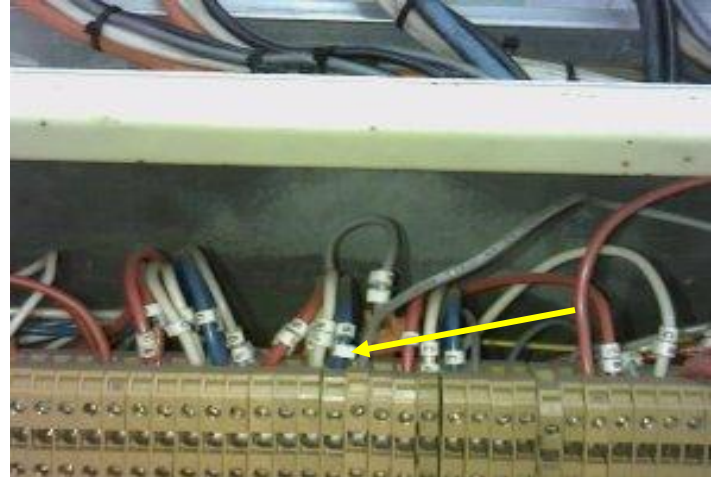
<b>Temperature Rise:</b>	<b>14.6</b>
<b>SEVERITY:</b>	<b>MEDIUM GRADE</b>
28/02/2013 9:32:09 a.m.

Location	Sample only.
Equipment	Sample only.
Area	Old control room.

<table><tr> <td>Temperature Rise Measured Value</td> <td>14.6</td> </tr><tr> <td>Ref Temp Temperature</td> <td>27.0 °C</td> </tr><tr> <td>Ar1 Max. Temperature</td> <td>41.5 °C</td> </tr></table>

Investigate further as soon as possible, repair/replace as needed.

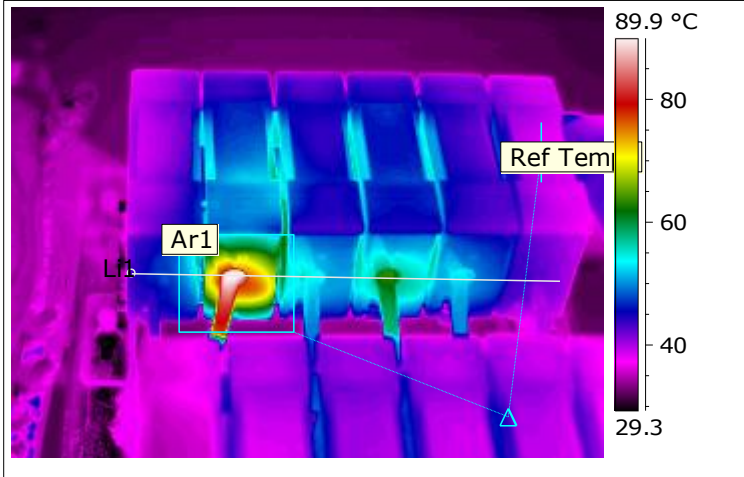
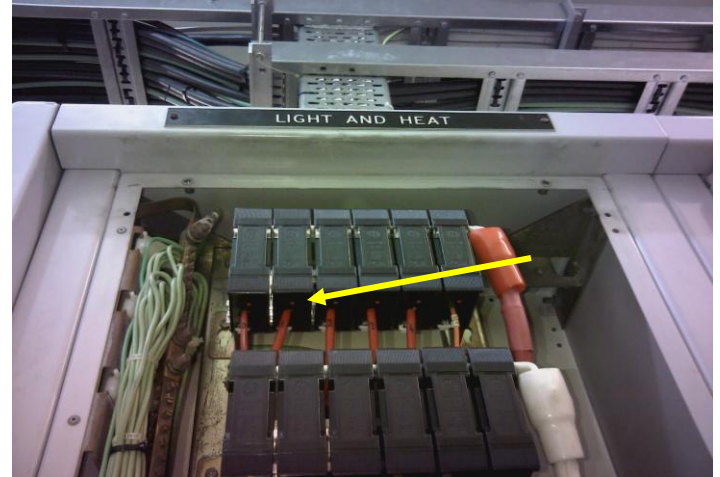
<b>Temperature Rise:</b>	<b>54.2</b>
<b>SEVERITY:</b>	<b>SEVERE GRADE</b>
6/05/2013 3:37:51 p.m.

Location	Main plant room.
Equipment	Sample only
Area	Sample only

<table><tr> <td>Temperature Rise Measured Value</td> <td>54.2</td> </tr><tr> <td>Ref Temp Temperature</td> <td>38.4 °C</td> </tr><tr> <td>Ar1 Max. Temperature</td> <td>92.5 °C</td> </tr></table>

Investigate now, repair/replace immediately.

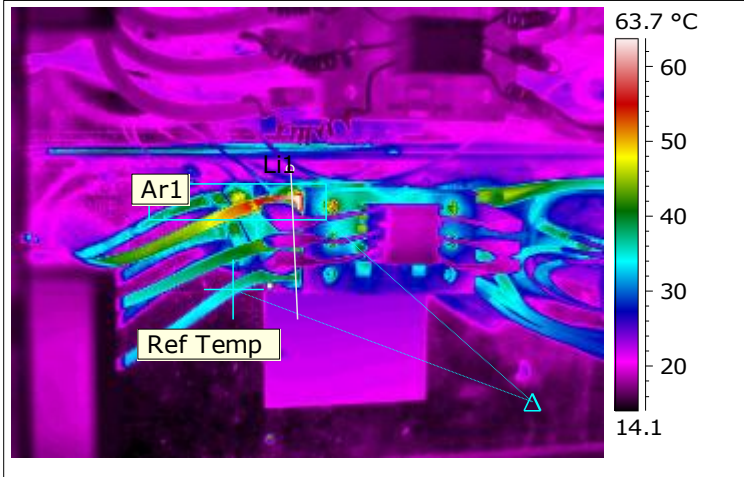
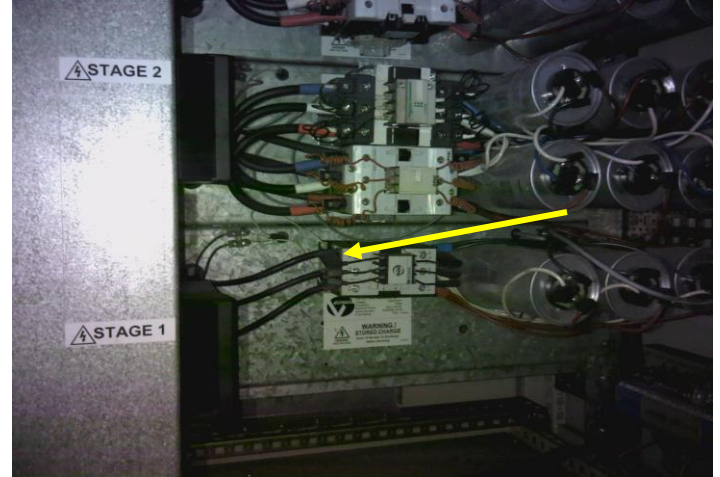
<b>Temperature Rise:</b>	<b>29.8</b>
<b>SEVERITY:</b>	<b>MEDIUM GRADE</b>
29/05/2013 10:49:59 a.m.

Location	Area 6 - second floor.
Equipment	Stage 1
Area	Power factor correction

<table><tr> <td>Temperature Rise Measured Value</td> <td>29.8</td> </tr><tr> <td>Ref Temp Temperature</td> <td>35.3 °C</td> </tr><tr> <td>Ar1 Max. Temperature</td> <td>65.1 °C</td> </tr></table>

Investigate further as soon as possible, repair/replace as needed.

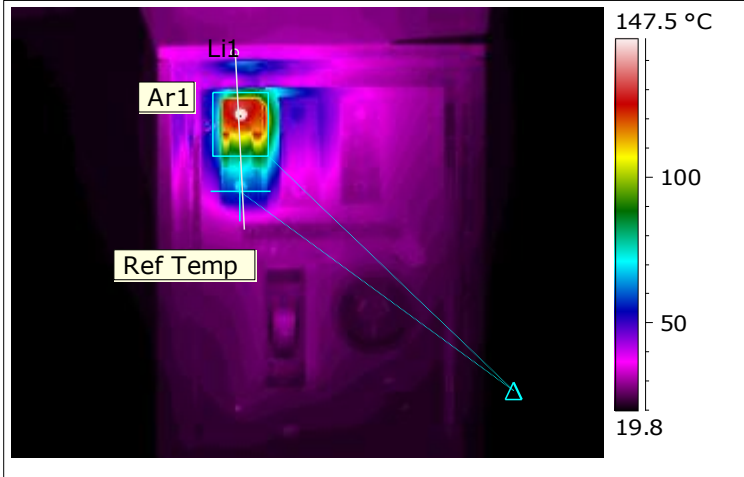
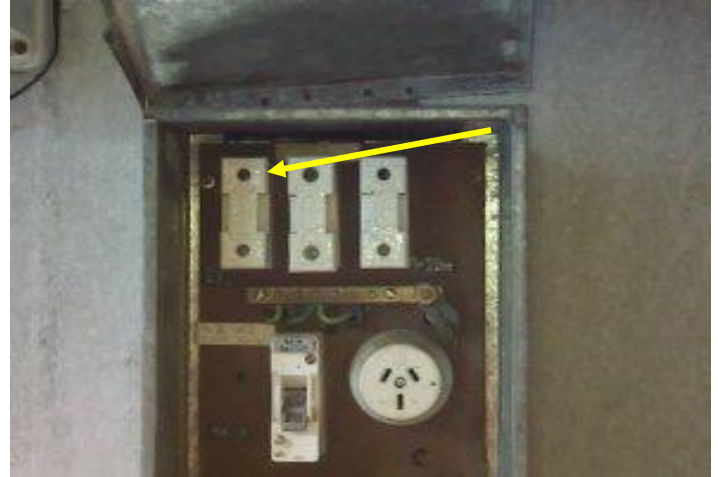
<b>Temperature Rise:</b>	<b>98.8</b>
<b>SEVERITY:</b>	<b>SEVERE GRADE</b>
12/02/2013 9:12:10 a.m.

Location	Shed 2
Equipment	Distribution board
Area	Interior wall

<table><tr> <td>Temperature Rise Measured Value</td> <td>98.8</td> </tr><tr> <td>Ref Temp Temperature</td> <td>61.4 °C</td> </tr><tr> <td>Ar1 Max. Temperature</td> <td>&gt;160.2 °C</td> </tr></table>

Investigate now, repair/replace immediately.
