Infrared Thermography and Water Damage Assessment

Noah Ceteras / Scott Wood
Four Star Cleaning and Restoration / Building Science Institute

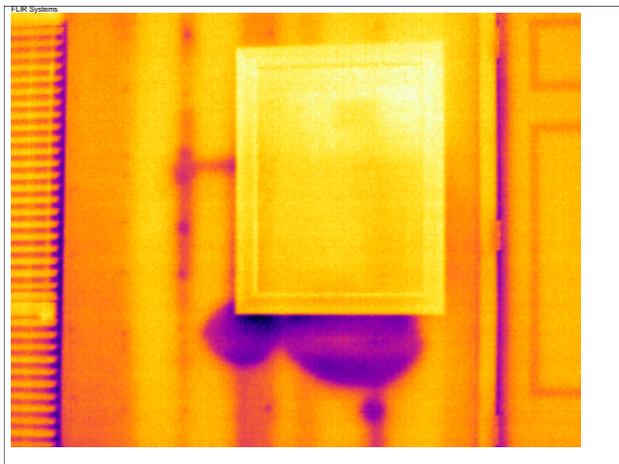
Figures 1 and 2 show a thermal and digital image of water damage that occurred following a severe rain storm. The homeowners had called complaining that their carpet was wet. Inspection with use of infrared thermography revealed a much greater problem than just wet carpet. Several large areas of affected wallboard were detected in both their 1st floor living room as well as their second floor bonus room. This detection of water intrusion using infrared thermography allowed for the timely placement of drying equipment as well as material removal in the most severely affected areas.

Figure 1. Thermal image of water intrusion.

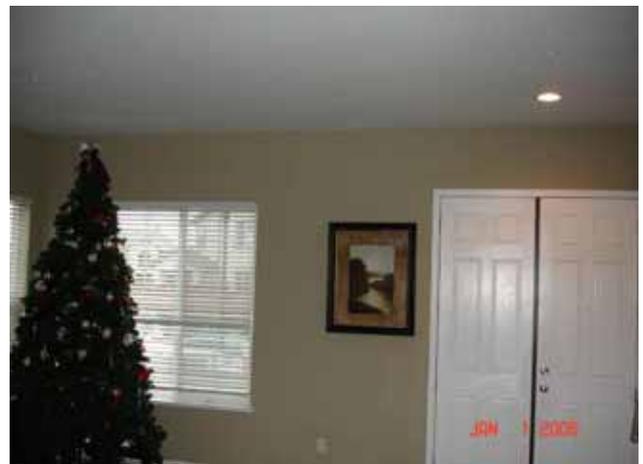
Figure 2. Digital image of water intrusion.

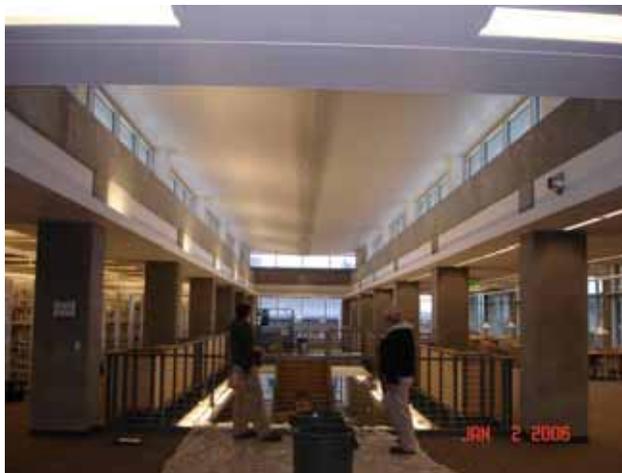
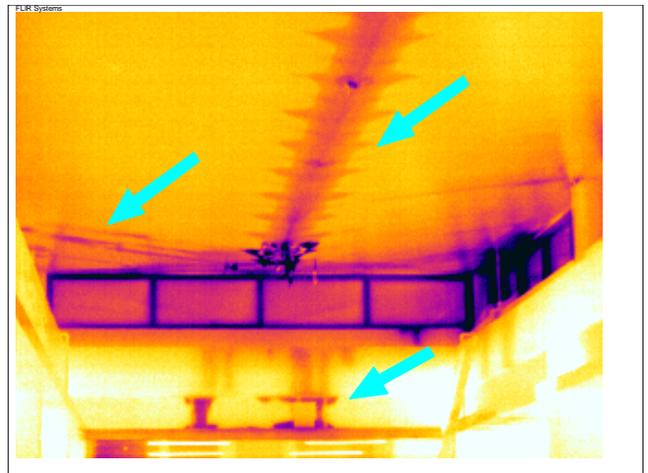
Use of handheld thermal imaging devices has changed the way the restoration industry does business. Walking into a 20 story high rise is no longer as much of a daunting task as it once was. Using the thermal imager during a general walk through the thermographer is able to locate affected areas without content removal or lift systems. Inspection of difficult to reach walls or ceilings can easily be observed. Infrared thermography helps facilitate the placement of drying equipment at the most appropriate (affected) areas. Figures 3 & 4 show a 20 foot ceiling over a large stairwell, creating an almost impossible place to reach. Use of a FLIR B-20 camera showed the extent of damage within seconds.

Figures 3-4, Shown above are a digital and thermal image of a library in Northern California affected by a large rain storm

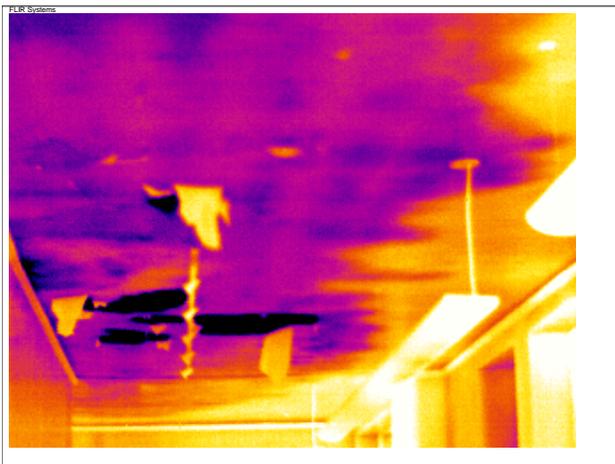
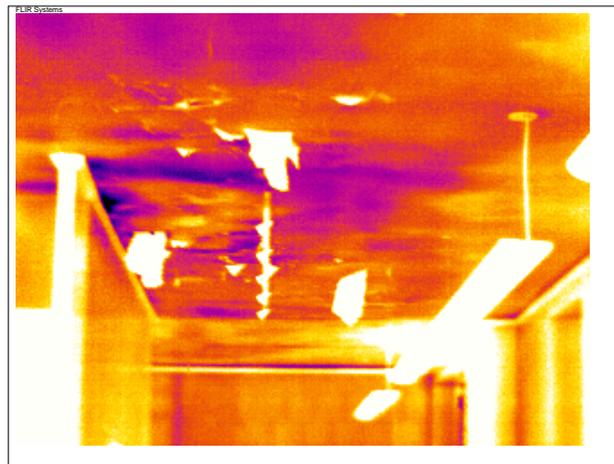
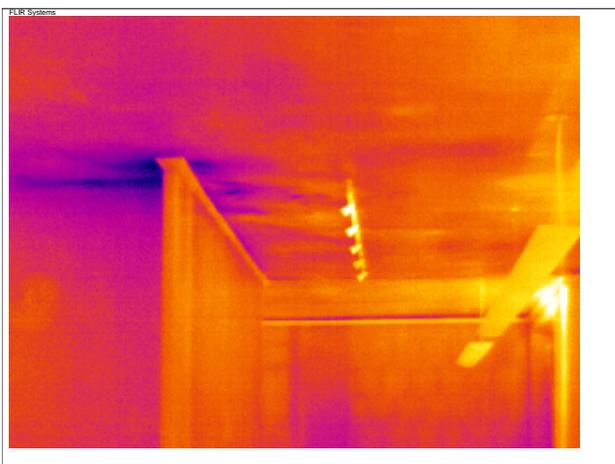
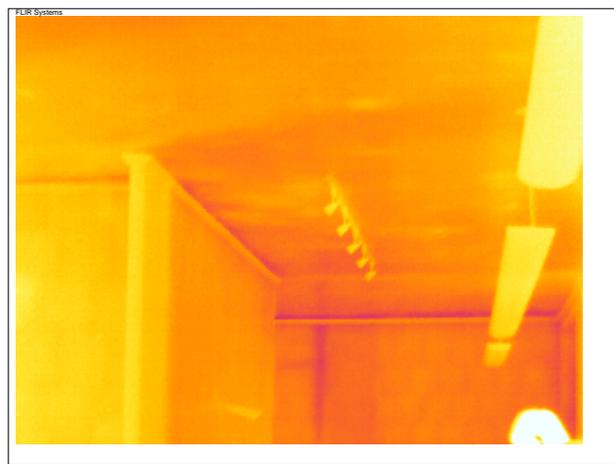
Moisture mapping (thermal and digital images showing affected areas) is an extremely valuable procedure for many clients affected by water damage. Moisture mapping provides conclusive documentation of affected areas. This process documents effectiveness of the dry down process and provides effective proof that the site was dry when the job is completed helping to release you of liability. Moisture mapping provides additional documentation to prove whether materials are dry, whether to add additional equipment or if removal of affected material is needed. By careful use of noting your vantage point, images can be taken to show your client the dry-down process during each inspection. Using a good frame of reference the thermographer can usually take images from roughly the same vantage point, creating a great summary of the dry-down process. The images below show thermal images from roughly the same vantage point, however some differences are noted in each thermal image.

Figures 5-8: Thermal images of water damage over the course of two weeks.

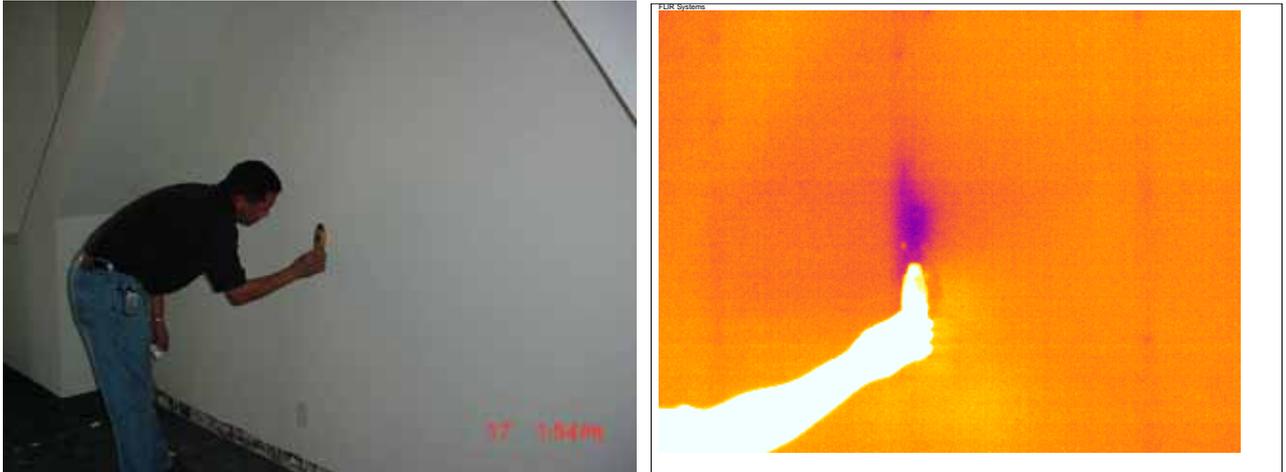
Good note taking is the key to providing a good report for your client. Taking note of the indoor/outdoor temperature, outdoor conditions during the time of inspection, moisture meter readings and thermal/digital image numbers are all useful pieces of information for your report. Using a moisture meter will help substantiate the findings while using the infrared imaging device. Shown below is use of a moisture meter to verify the cooler spot found by infrared thermography on a wall, verifying it to be moisture.

Figures 9-10: Missed areas easily found with infrared thermography and verified with moisture meter survey.

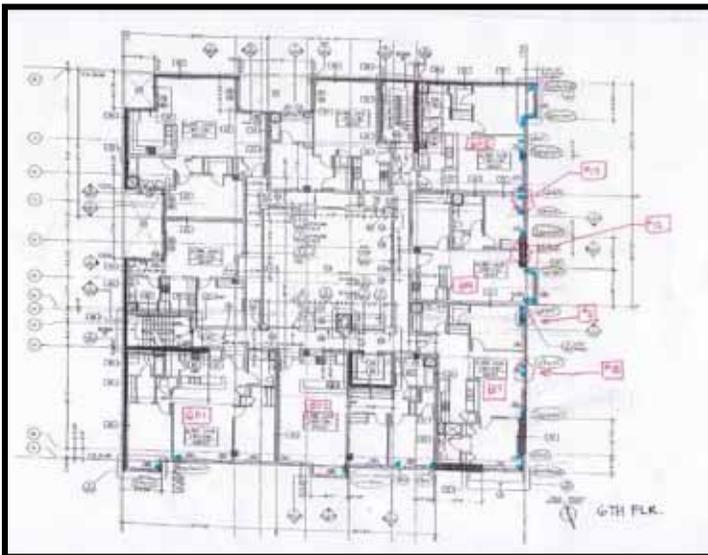
Being able to diagram what areas have been affected by water is another useful way to provide documentation of your findings. If you are fortunate enough to obtain a copy of building blue prints, it can make the mapping process that much easier. However, in many cases when called to a large loss claim in the middle of the night, it is sometimes impossible to get blue prints or maps on the spot. In these cases a hand drawn map will suffice. Providing a map/diagram of findings can not only be useful when providing a report to the client but also helpful to the inspector. Taking note of your image numbers and the areas of the building to which they correspond, can provide a clear overview of the project.

Figure 11-12: Above is an example of a map/diagram showing areas of water damage
