Use of the Blower Door with IR/Thermal Imaging for Residential Building Diagnostics

Howard Vics
Building Performance Consulting of NY

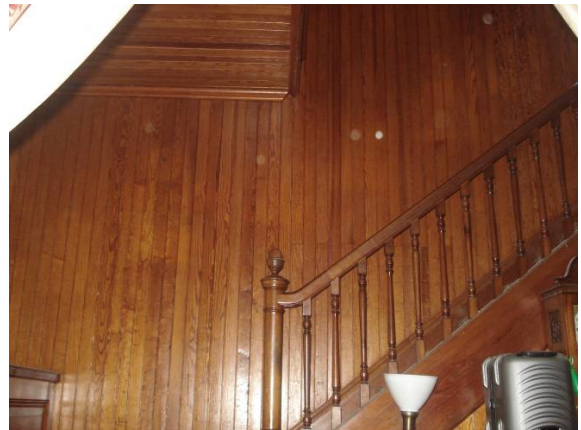
Figure 2. This IR image, taken in the winter, shows wall cavities with no insulation. Heat is lost more quickly since there is no insulation, as there is in surrounding cavity and is therefore colder than the surrounding, properly insulated wall cavities. Associated visual photo on right.

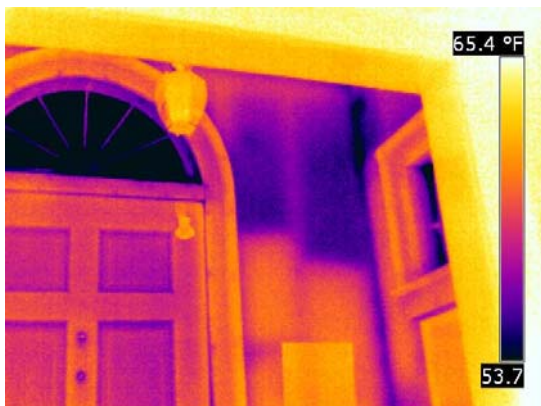
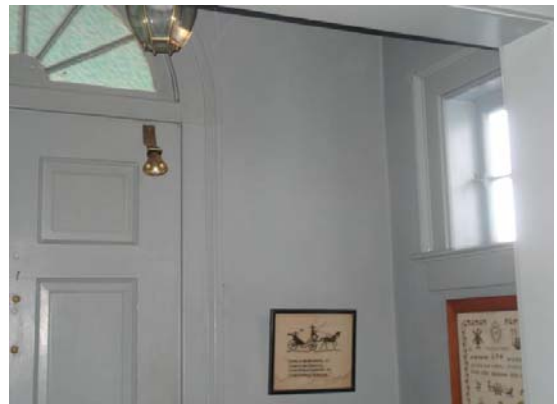
Figure 3. Thermal Image shows section of wall adjacent to the entry door where insulation is present and where it is missing. Since the resistance to heat flow (R-value) is less in the section of wall without insulation, the heat loss will be greater. . Associated visual photo on right.

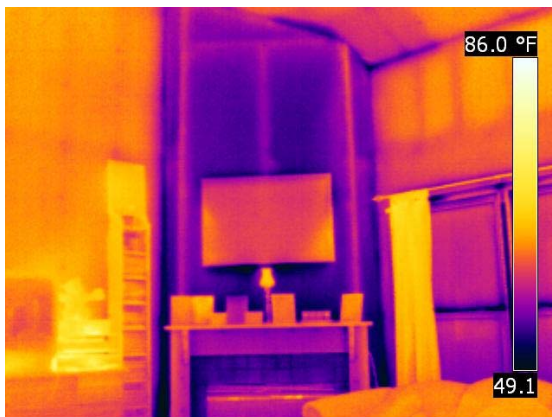
Figure 4. Thermal image shows colder surface in boxed out chimney where the cavities are not insulated. . Associated visual photo on right.

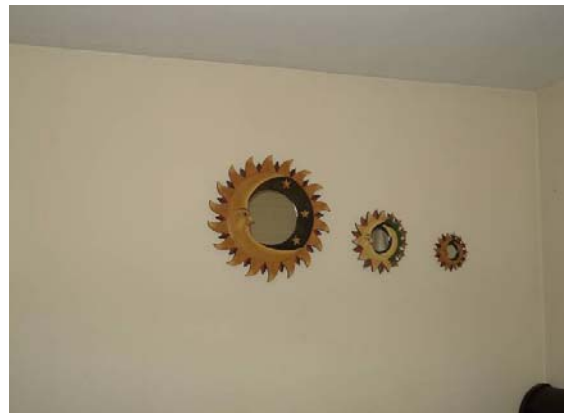
Figure 5. Missing Insulation leads to differential heat loss due to disparate thermal conductivities. Associated visual photo on right.

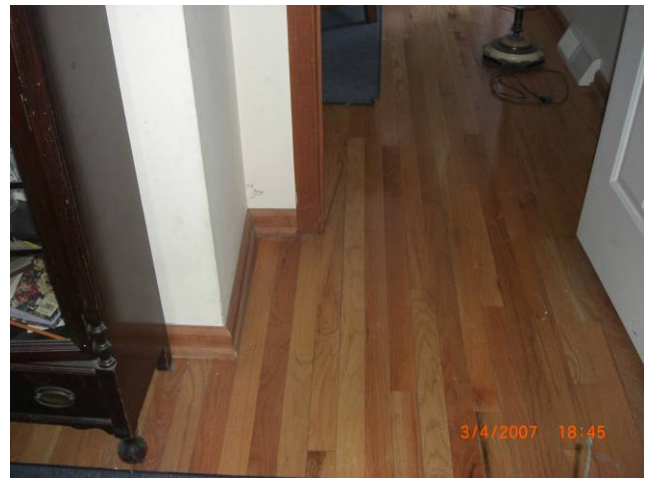
Figure 7. IR Image shows infiltration where interior wall meets the floor. This is taken above an unheated basement.

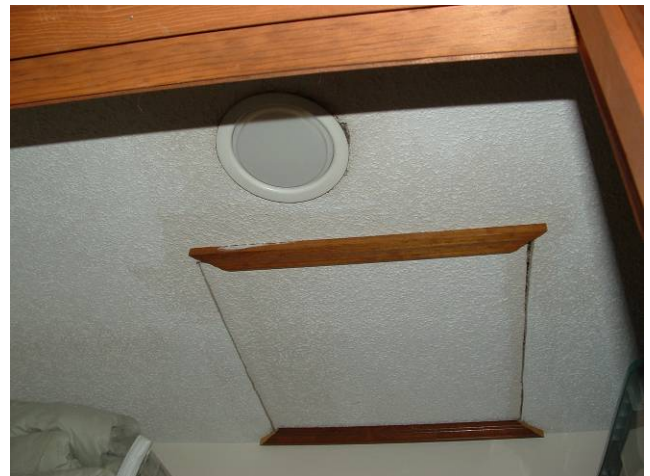
Figure 8. Blower door enhanced Image shows infiltration from around the recessed light fixture and leakage from the attic hatch.

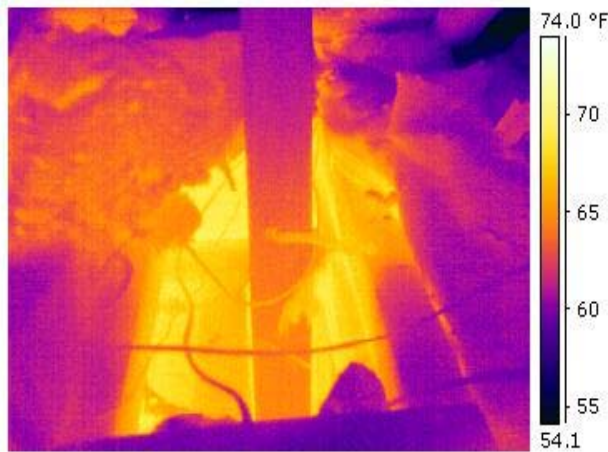
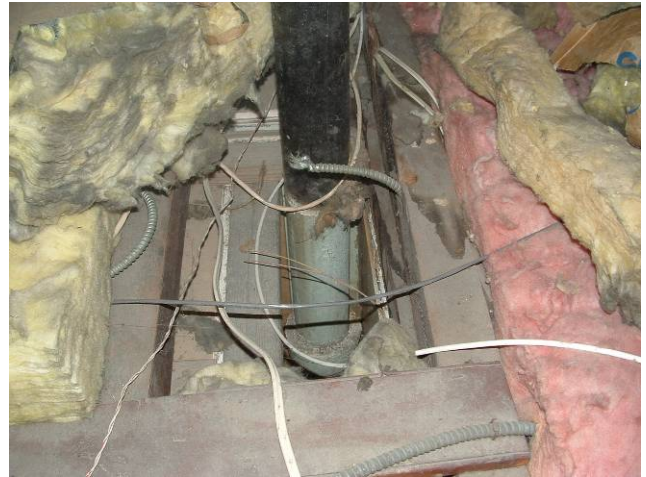
Figure 9. IR Image shows the heat escaping through the pipe chase and leaking into the attic. Image right shows how much bigger the opening is than the soil pipe shaft.

Figure 9 gives a good example of a thermal bypass via a pipe chase. Figure 10 gives an example of a thermal bypass via a chimney chase and Figure 11 for an attic partition wall. All these examples show considerable heat lost to the outside world.

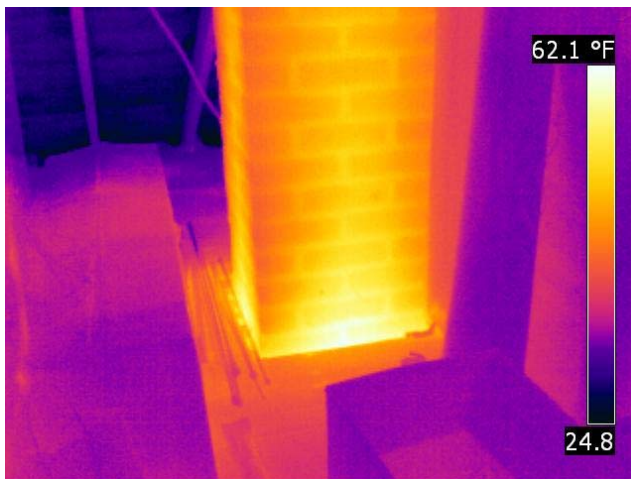
Figure 10. IR image of thermal bypass at chimney chase.

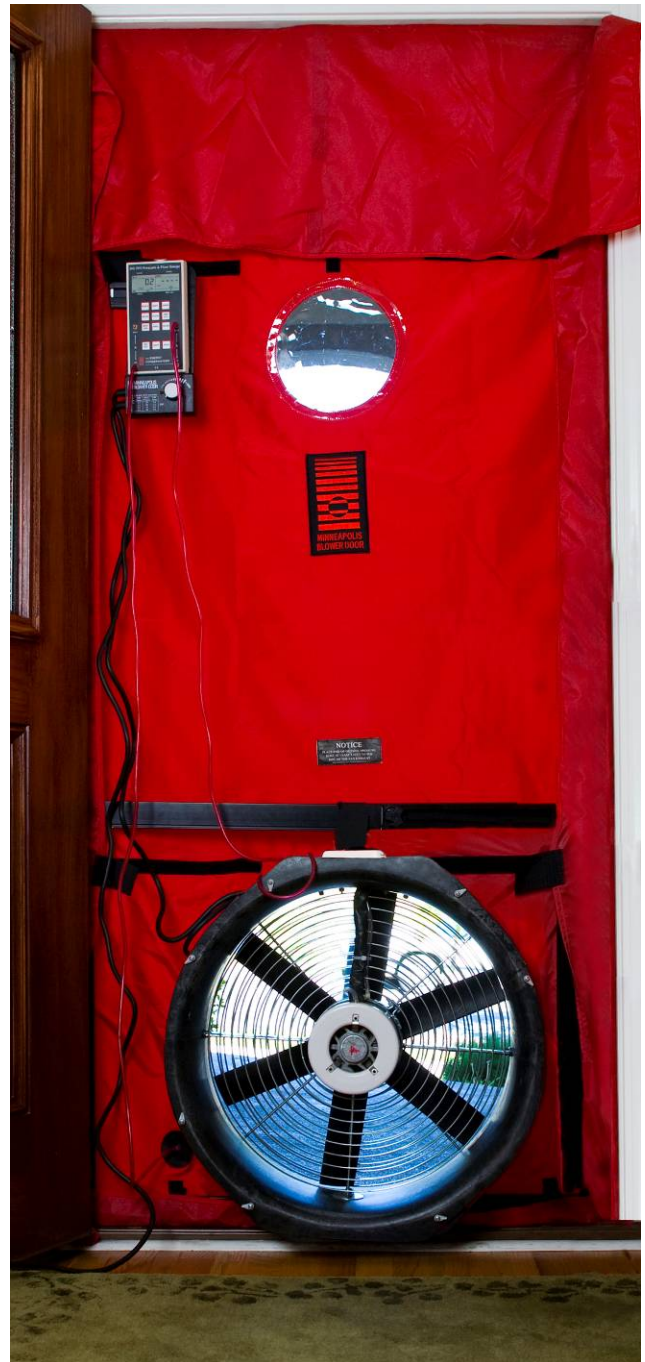
Figure 12. Blower door installed in residential outside doorway.

The Blower Door (Figure 12) is used to create an artificial pressure difference between the interior of the structure and outside of the building. The standard differential pressure for residential diagnostics is -50 Pa (Pascals, see Appendix B), which is equivalent to a 20 mph wind blowing against all sides of the structure simultaneously. The blower door quantifies the air infiltration rate in terms of “Cubic Feet per Minute”. This number is then compared to the “Building Airflow Standard” (BAS) established by ASHRAE standard 62.2-2007

For diagnostic purposes, the interior is de-pressurized with reference to the outside. As a result, the outside air is pulled through the discontinuities (gaps, cracks and holes) of the building envelope and cools (or heats) the interior surfaces

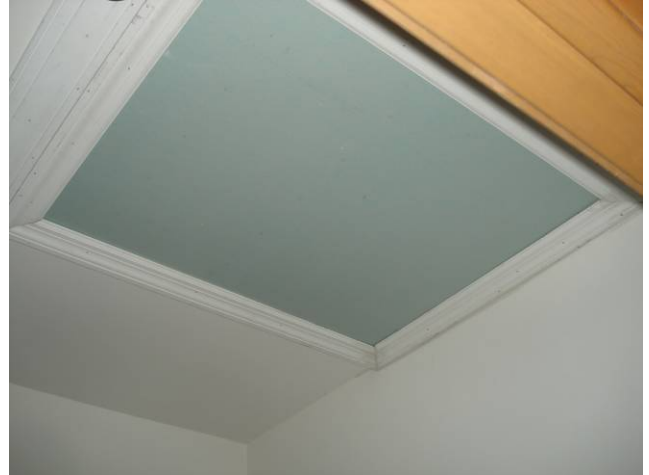
Figure 14. Thermal image shows the “wispy” effect of blower door induced infiltration. Here the outside air is colder than inside.

Figure 14 shows another attic hatch, this time leaking cold attic air into the living space during a blower door test.

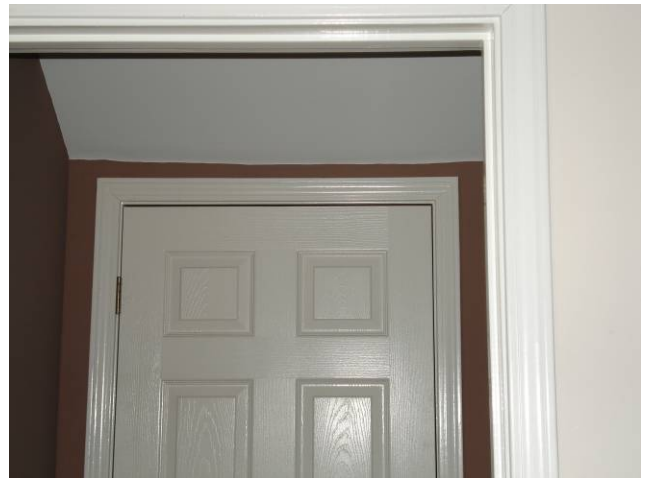
Figure 15. IR image indicates air Leakage along the top of molding. Temperature outside the thermal boundary is higher than inside

Figure 15 shows an example of a poorly constructed outside door frame. This appears to be more a construction lack of caulking problem rather than a weather-stripping problem. Often blower door testing indicates problems that can be fairly easy to fix with weather-stripping or proper caulking/sealing. Compared to other problems such as missing insulation the infiltration/exfiltration repairs can be much less intrusive and

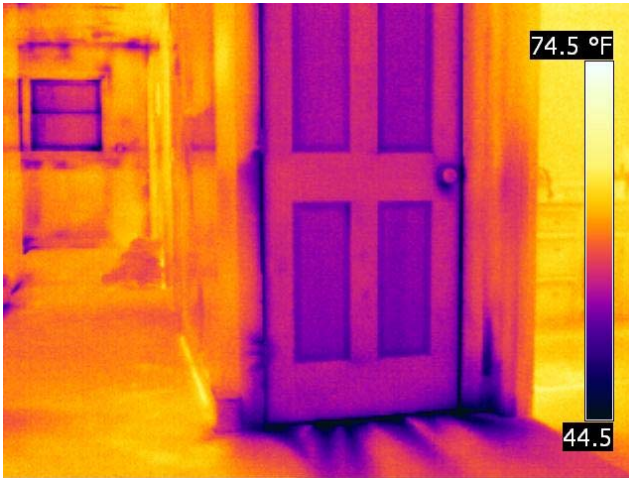
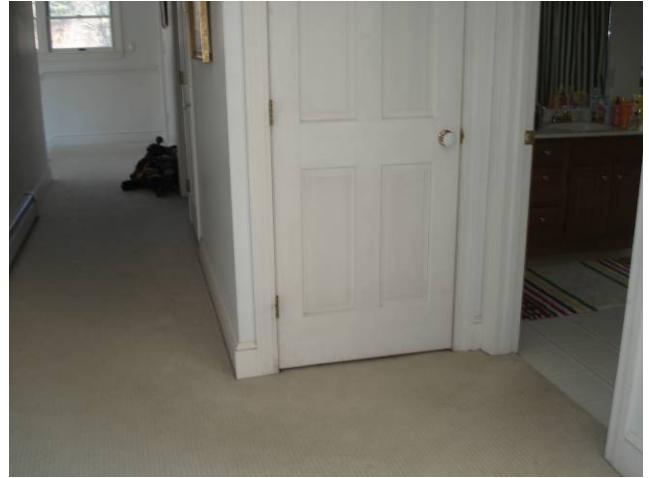
Figure 16. IR image showing air Leakage at the bottom of attic access door.

Figure 16 is yet another example of air leakage found during blower door testing. This time it is an attic doorway. Often these are treated as interior doors when they should be considered exterior. Weather stripping and perhaps some insulation added to the attic side of the door would really improve this problem. And it is a very inexpensive and quick fix.
