Using Thermography to Find a Class of Latent Construction Defects in Drain and Vent Pipes

Ken VanBree, Imaging Perspective, LLC
Scott Wood, Building Sciences Institute

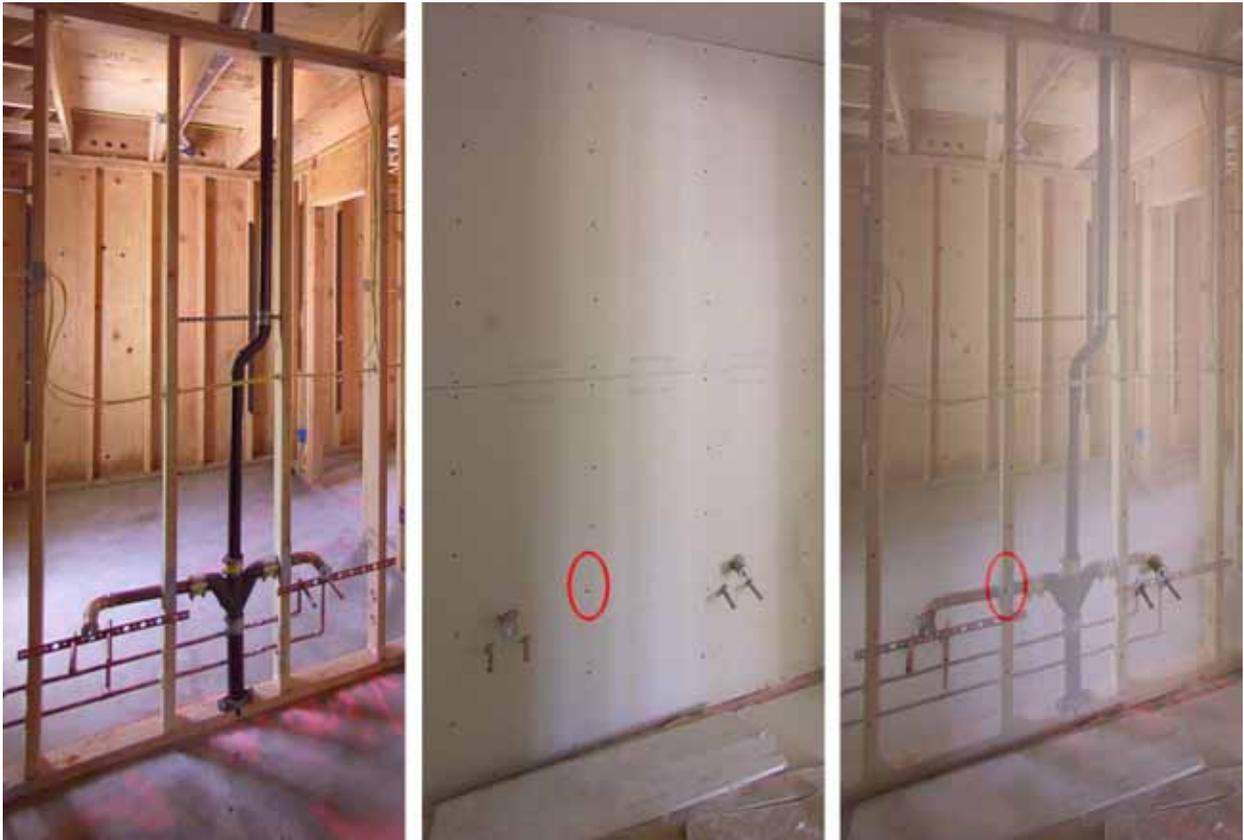
Figure 1. A typical residential construction wall with copper and ABS pipes, wires and protection plates

or years after construction is complete. Figure 1 shows a wall in a typical residential construction project where pipes and wires contained within the wall are protected by nailing plates. The image on the left shows the wall before wallboard is installed. The middle image shows the wall after installation of wallboard. The red ellipse on the wall marks the head of a screw used to install the wallboard. The image on the right shows an “X-ray” view of the wall where the screw in question may have penetrated a copper drainpipe. While nailing plates and other defensive techniques have reduced the number of occurrences of this class of defect, they haven’t completely eliminated them. In a paper given at InfraMation 2005¹, the authors outlined a technique for using infrared thermography to detect this class of latent defects in copper water pipes carrying hot water. A subsequent paper² extended the technique to cold water pipes. In this paper we extend the technique to plastic drain and vent pipes.

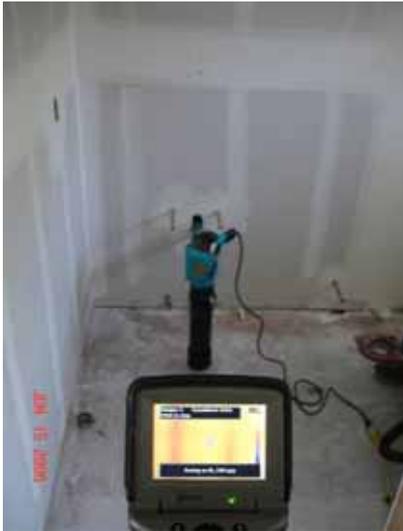
Figure 4 Image of wall under test and the positioning of the infrared camera.

In order to test this technique in a real world construction setting we contacted a friendly contractor who agreed to help us devise a realistic test. Figure 4 shows the positioning of the infrared camera used during the test. The left hand image in Figure 5 shows a portion of a bathroom under construction. The wall board has

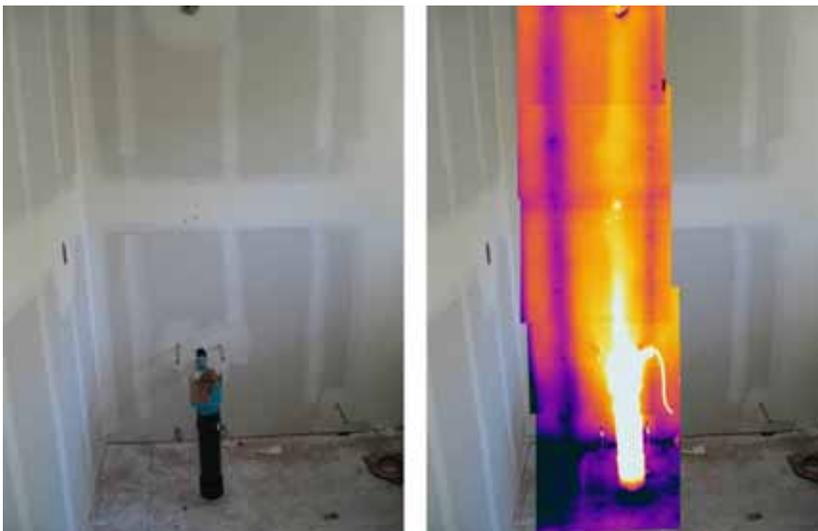
Figure 5 Image of wall under test (left) and an overlay of the final infrared thermogram of the wall under test.

been installed and taped but the bathroom cabinetry has not yet been installed. Three screws have been inserted in the wall board above the water pipes and drain at the level where bathroom cabinetry would typically be installed. The image on the right is a composite image where a series of infrared thermograms have been overlaid on the original photograph. The infrared thermograms were taken after the conclusion of a test in which the authors forced hot air from a heat gun through the vanity drain. The infrared thermograms show that the topmost of the three screws heated above the temperatures of the lower screws inserted into the wallboard. This upper screw demonstrates a latent defect because it has penetrated the vent pipe while the other two screws have not. The thermograms also show the outline of the vent stack between the studs behind the wallboard.

Although the bottom right screw shown in Figure 5 is in direct line with the vent pipe it does not show up as a heated object (defect) like the upper screw. This is because it only touches but does not penetrate the ABS pipe, which is not an efficient conductor of heat (plastics 0.2-0.5 k (W/m-K)). If the vent pipe were copper rather than ABS, this bottom right screw would have shown up as a defect as well, since copper is a good heat conductor (401 k (W/m-K)). In the case of a copper vent pipe a steel screw in contact with a copper pipe would eventually lead to corrosion through galvanic action between the different metals. ABS pipe will not corrode in the same way, so a screw that touches but does not penetrate the pipe will not compromise the integrity of the pipe.
