Detection of Moisture within Building Enclosures by Interior and Exterior Thermographic Inspections

*Antonio Colantonio, Public Works and Government Services Canada
Scott Wood, Building Science Institute*

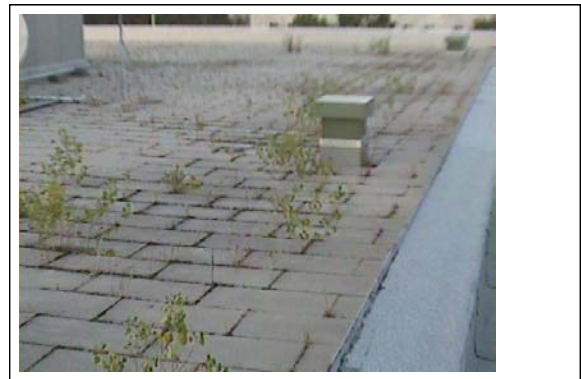
Figure 2. Visual of concrete clad insulation over inverted roof membrane, no visible wetting on concrete.

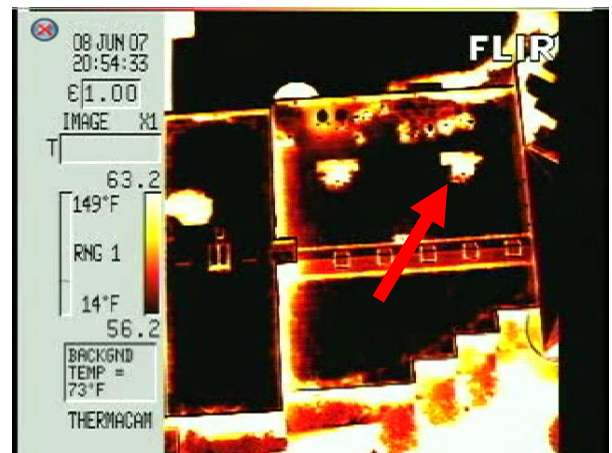
Figure 6. Same area shown in Figure 5 (see arrow) taken at 8:54pm in the evening during a flyover. (Image courtesy of Lee Durstin, BCRA)

Detection of moisture within built-up roofs can be carried out from three distinct distances associated with; 1) by walking under or over the roof assembly (Figures 3 and 4), 2) surveying from higher adjacent roofs (Figure 5), or 3) by fixed wing airplanes or helicopters (Figures 6 and 7). All are acceptable methodologies when suitable inspection conditions are present and appropriate infrared imagers are used. Small roofs may be more cost-effective to inspect by simple walk through using inexpensive 10K to 20K pixel imagers. Large roofs with vantage points from other adjacent roofs make hand-held inspections cost effective if employing 80K pixel imagers with better spatial resolution capabilities. For very large low-sloped roofs, or for many roofs in one geographical location or campus, aerial inspection is the quickest and most efficient means of collecting data on BUR and low sloped roof moisture intrusion. Dedicated high spatial resolution imagers (300K pixel or higher) are required for aerial inspections to ensure suitable spot size resolution to define moisture patterning and roof features. Focus and high-speed vibration issues need to be addressed in data collection methodologies from aerial fixed-wing or helicopter inspections for both fixed mounted and handheld imagers. These issues severely hamper image resolution if not dealt with.

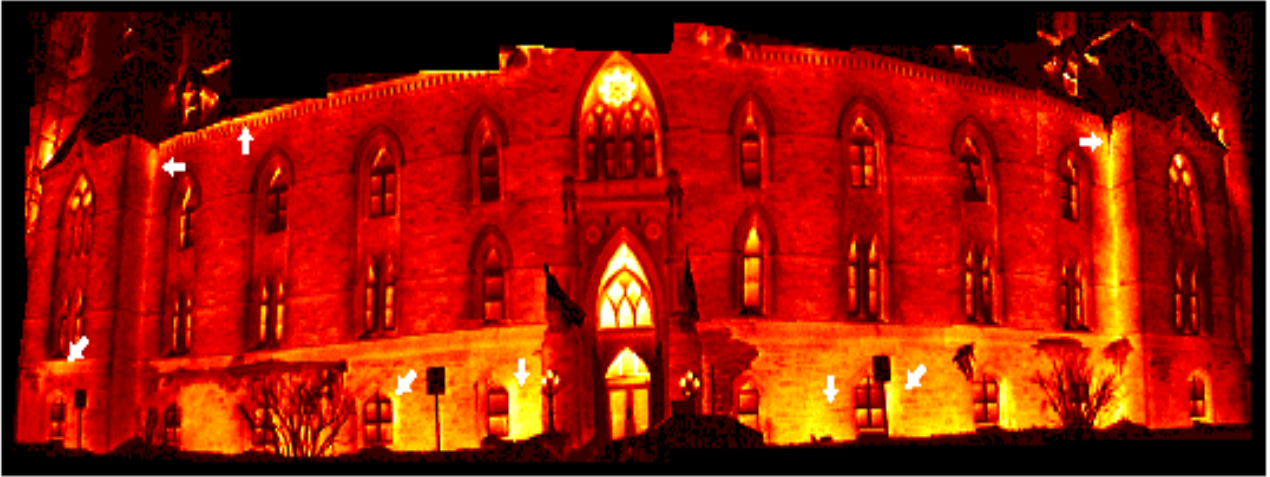
Figure 14. Ground floor of solid masonry wall assembly illustrates warmer surface temperatures due to rising damp from ground water in foundation wall. Melt water penetration into walls also visible at inside corner on right side of image.

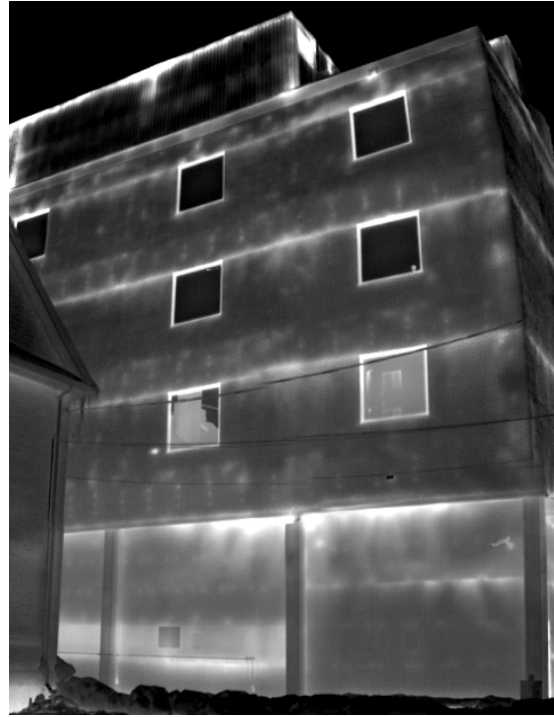
Figure 20. Positive Building Pressure (+25 Pa), To \approx 11 °C (12.2 °F)

Much of the mottled surface patterns found in the masonry cladding in Figures 19 and 20 illustrate this heat loss mechanism. The intensity of the thermal pattern is affected by the amount of moisture within the assemblies and the saturation level. In instances of very low exterior temperatures, it is possible to be viewing both phase changes (vapor to water on the inside sections of the enclosure, and water to ice on the exterior sections of the enclosure).

Figures 19 and 20 illustrate exothermic phase change patterns heat at below freezing temperatures. Of special interest is the pattern at the upper roof parapet in Figure 19 where moisture is freezing due to cold air temperatures within the wall assembly due negative pressures.

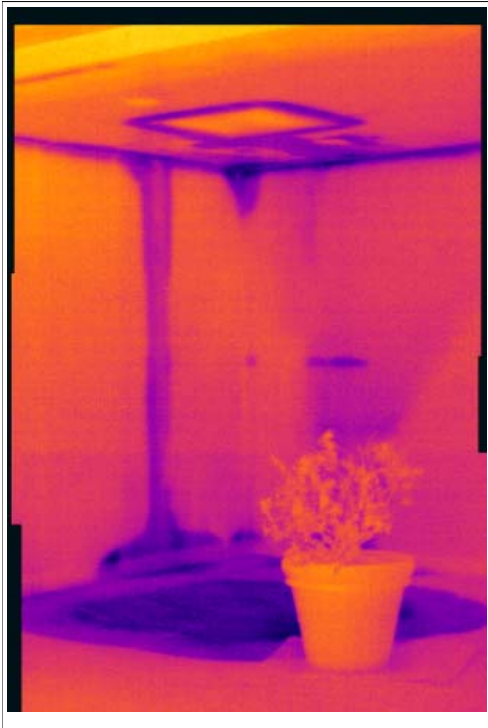
Figure 21. Fire sprinkler system leak observed on an interior painted wall and carpet. Initial wetting and drying appear much defined.

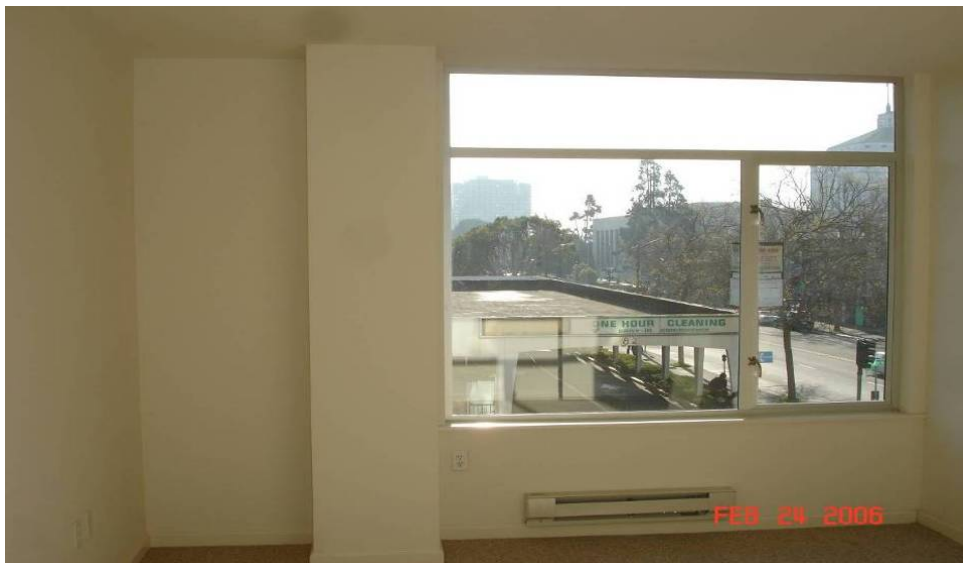
Figure 25. Interior surfaces of exterior walls showing no visible wetting other than flooring.

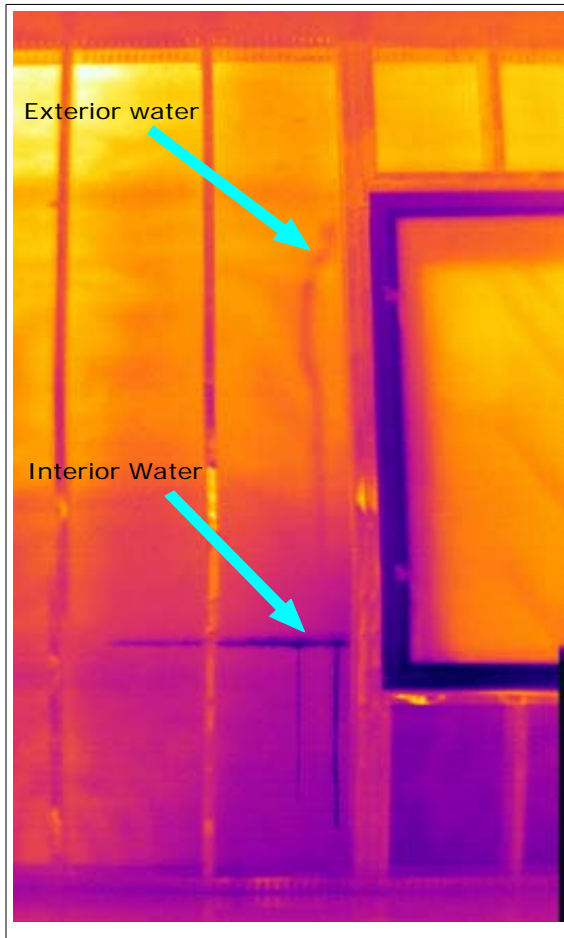
Figure 27. Moisture entering the exterior stucco at the window header, penetrating into the interior at a lower point.

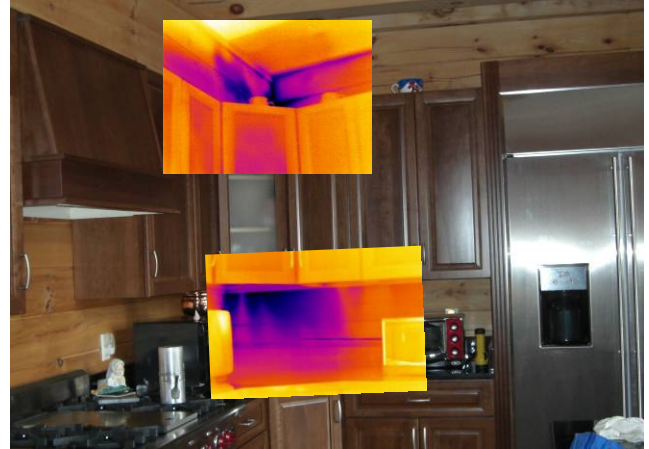
Figure 30. Air infiltration during pressure testing. (Image courtesy of Janet Vics, Infrared investigation)

Interior inspection of residential, large commercial or high rise buildings are generally done after exterior inspections determined that a potential problem exists. They are done to confirm results of exterior inspections. In cold climates, negative building pressure inspections during the heating season could result in condensation potential on interior surfaces or in interstitial spaces or materials close to the building interior. Unfortunately moisture patterning at air leakage points on interior surfaces is overpowered by the mass transfer heat loss pattern of the air leak. The greater the temperature differential between interior and exterior, the less likely moisture patterns are visible in the infrared during leakage testing. If negative building

pressure leakage testing is carried out for long durations, it could be possible to detect moisture accumulation after the air testing while the building is in a neutral or slightly positive pressure condition and the mass transfer of warm interior air has not dried out the moisture around the leakage points.
