Detection of Moisture within Building Enclosures by Interior and Exterior Thermographic Inspections

*Antonio Colantonio, Public Works and Government Services Canada
Scott Wood, Building Science Institute*

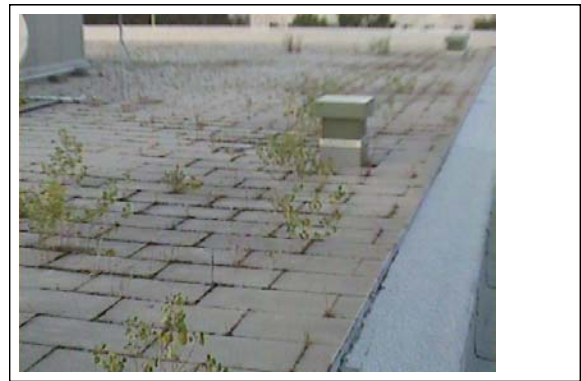
Figure 2. Visual of concrete clad insulation over inverted roof membrane, no visible wetting on concrete.

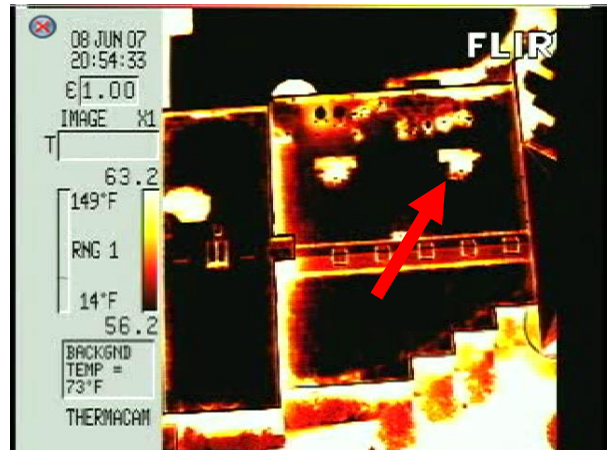
Figure 6. Same area shown in Figure 5 (see arrow) taken at 8:54pm in the evening during a flyover. (Image courtesy of Lee Durstin, BCRA)

Detection of moisture within built-up roofs can be carried out from three distinct distances associated with; 1) by walking under or over the roof assembly (Figures 3 and 4), 2) surveying from higher adjacent roofs (Figure 5), or 3) by fixed wing airplanes or helicopters (Figures 6 and 7). All are acceptable methodologies when suitable inspection conditions are present and appropriate infrared imagers are used. Small roofs may be more cost-effective to inspect by simple walk through using inexpensive 10K to 20K pixel imagers. Large roofs with vantage points from other adjacent roofs make hand-held inspections cost effective if employing 80K pixel imagers with better spatial resolution capabilities. For very large low-sloped roofs, or for many roofs in one geographical location or campus, aerial inspection is the quickest and most efficient means of collecting data on BUR and low sloped roof moisture intrusion. Dedicated high spatial resolution imagers (300K pixel or higher) are required for aerial inspections to ensure suitable spot size resolution to define moisture patterning and roof features. Focus and high-speed vibration issues need to be addressed in data collection methodologies from aerial fixed-wing or helicopter inspections for both fixed mounted and handheld imagers. These issues severely hamper image resolution if not dealt with.

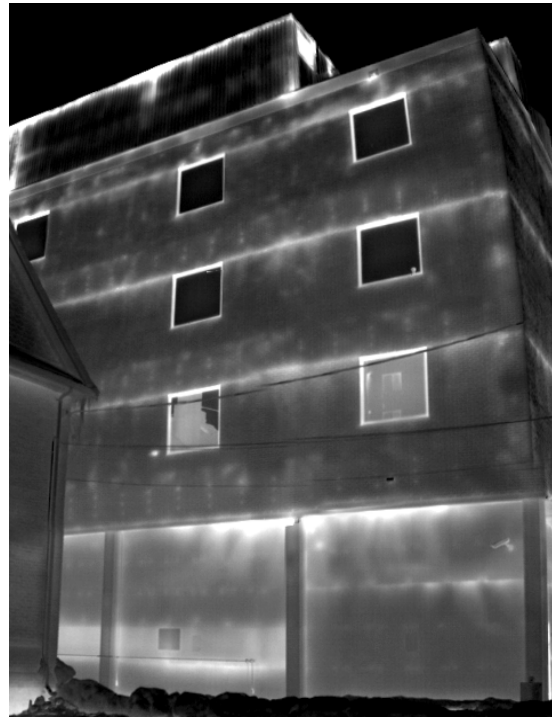
Figure 20. Positive Building Pressure (+25 Pa), To = -11 °C (12.2 °F)

Much of the mottled surface patterns found in the masonry cladding in Figures 19 and 20 illustrate this heat loss mechanism. The intensity of the thermal pattern is affected by the amount of moisture within the assemblies and the saturation level. In instances of very low exterior temperatures, it is possible to be viewing both phase changes (vapor to water on the inside sections of the enclosure, and water to ice on the exterior sections of the enclosure).

Figures 19 and 20 illustrate exothermic phase change patterns heat at below freezing temperatures. Of special interest is the pattern at the upper roof parapet in Figure 19 where moisture is freezing due to cold air temperatures within the wall assembly due negative pressures.
