SAMPLE REPORT

Customer	Sample
Site Address	Sample
Contact Person	Sample
Phone Number	Sample
Thermographer	Aaron Bryant ITC Level II thermographer Certification No. 2012NZ25N007.
Electrician	Sample

Report Summary

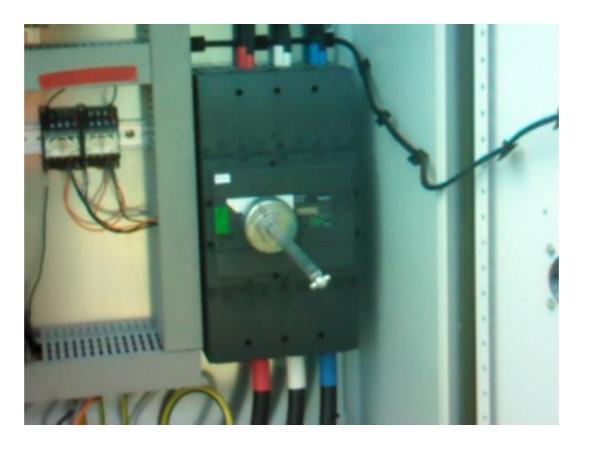
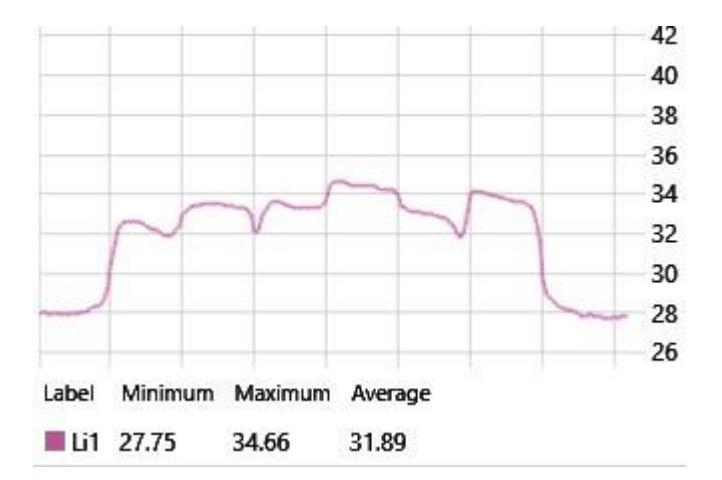
IR_17973.jpg | 09-Jan-19 | 9:17 AM

Measurements	
Sp1	32.6 °C
Bx1 Maximum	36.8 °C
Bx1 Minimum	26.8 °C
Dt1 (Bx1.Max - Sp1)	4.2 °C

No action required, continue to monitor.

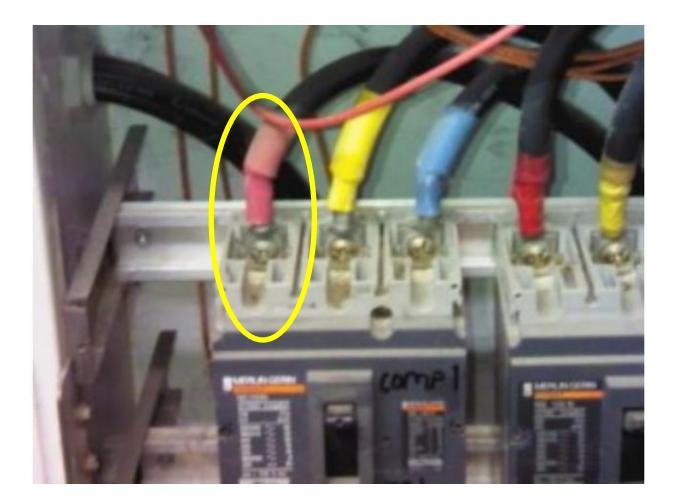
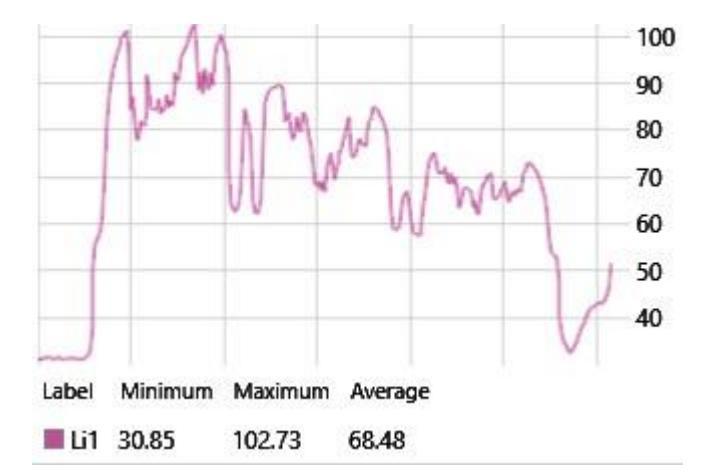
IR_5194.jpg | 06-Jun-15 | 1:45 PM

Measurements	
Sp1	54.4 °C
Ar1 Maximum	105.3 °C
Ar1 Minimum	43.9 °C
Dt1 (Ar1.Max - Sp1)	50.9 °C

Investigate now, repair/replace/explain immediately.

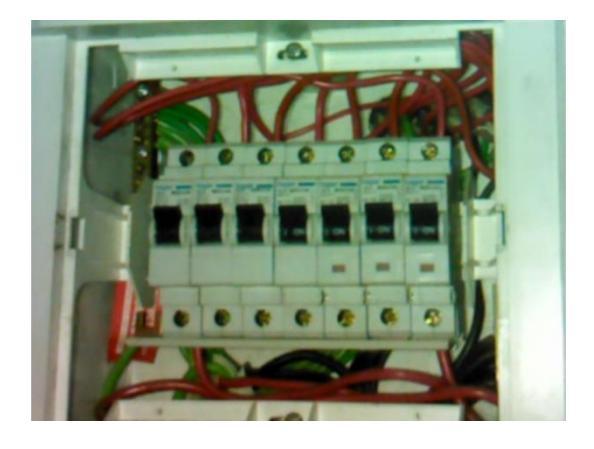
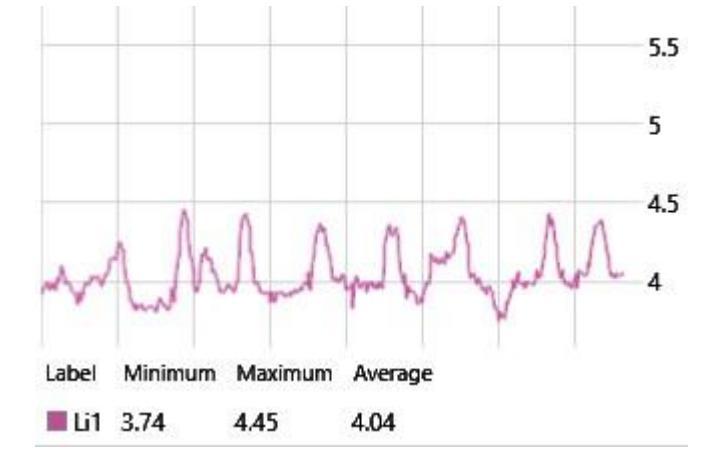
IR_9183.jpg | 06-Jul-17 | 8:57 AM

Measurements	
Sp1	4.7 °C
Bx1 Maximum	5.3 °C
Bx1 Minimum	4.4 °C
Dt1 (Bx1.Max - Sp1)	0.6 °C

No action required, continue to monitor.

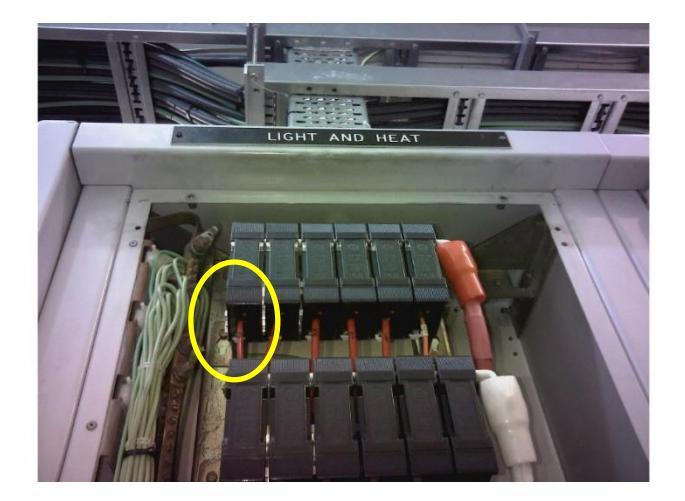
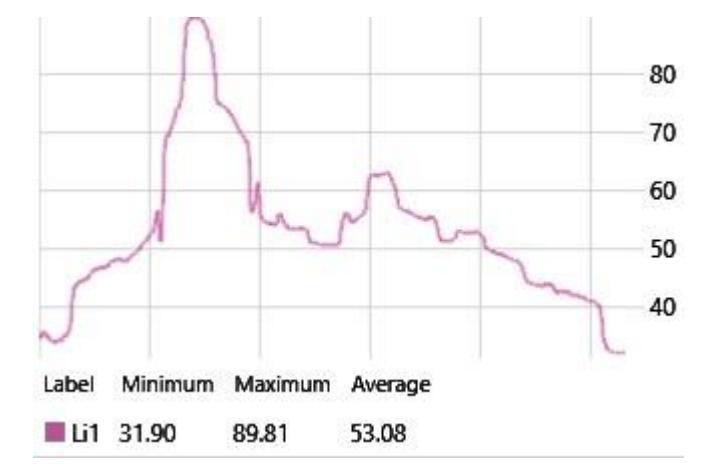
IR_0209.jpg | 29-Aug-13 | 6:56 PM

Measurements	
Sp1	40.0 °C
Bx1 Maximum	92.5 °C
Bx1 Minimum	33.5 °C
Dt1 (Bx1.Max - Sp1)	52.5 °C

Investigate now, repair/replace/explain immediately.

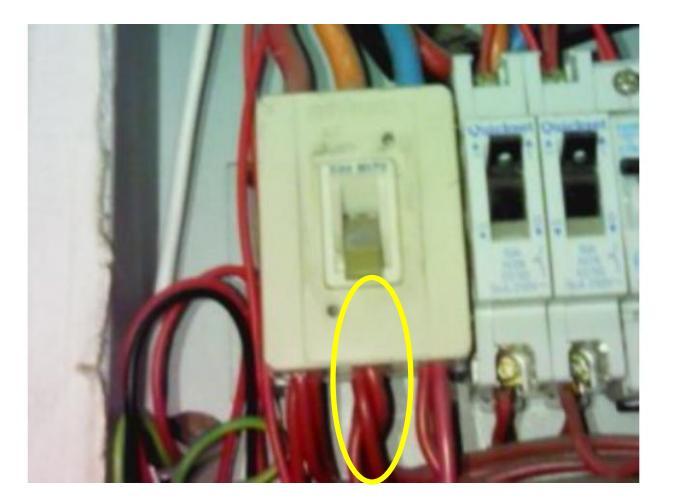
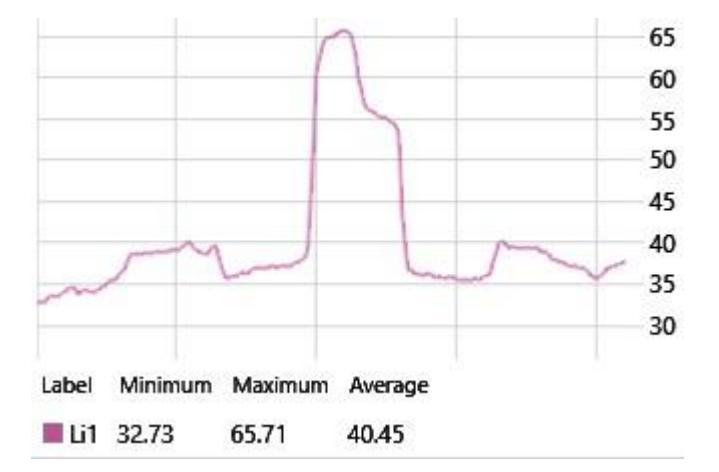
IR_5344.jpg | 06-Mar-15 | 11:13 AM

Measurements	
Sp1	38.7 °C
Ar1 Maximum	69.5 °C
Ar1 Minimum	33.3 °C
Dt1 (Ar1.Max - Sp1)	30.8 °C

Investigate further as soon as possible, repair/replace/explain as needed.

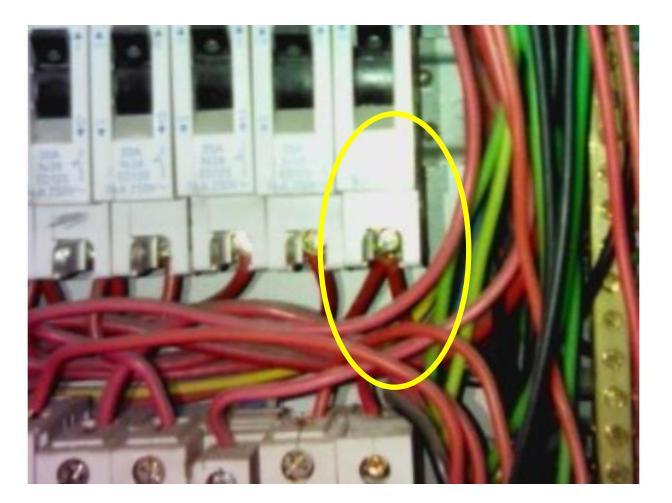
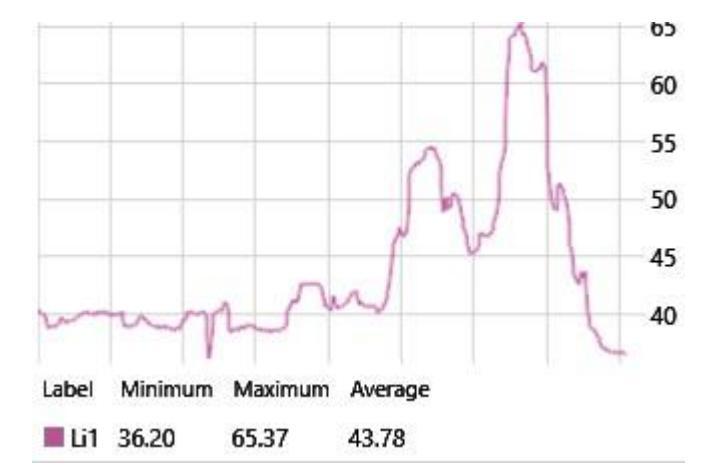
IR_5348.jpg | 06-Mar-15 | 11:15 AM

Measurements	
Sp1	40.1 °C
Ar1 Maximum	67.0 °C
Ar1 Minimum	32.7 °C
Dt1 (Ar1.Max - Sp1)	27.0 °C

Investigate further as soon as possible, repair/replace/explain as needed.

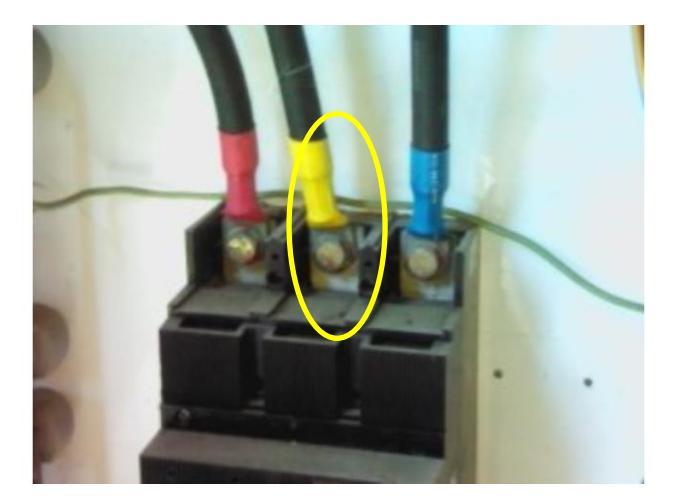
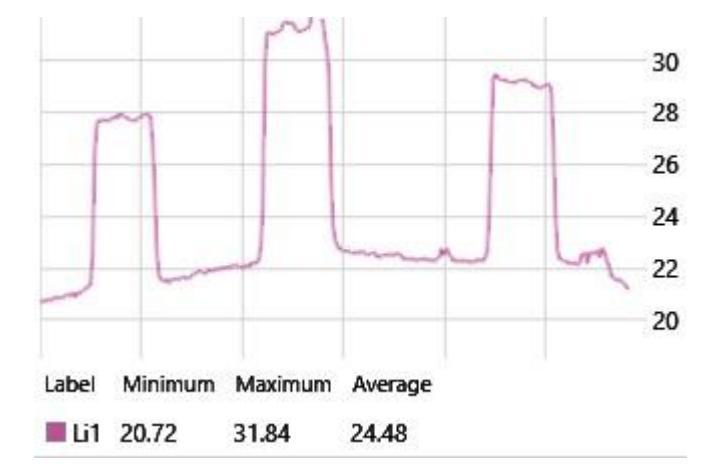
IR_7337.jpg | 30-Apr-15 | 12:01 PM

Measurements	
Sp1	27.8 °C
Ar1 Maximum	33.2 °C
Ar1 Minimum	21.0 °C
Dt1 (Ar1.Max - Sp1)	<mark>5.4 °C</mark>

Re-inspect at your next scheduled maintenance - continue to monitor.

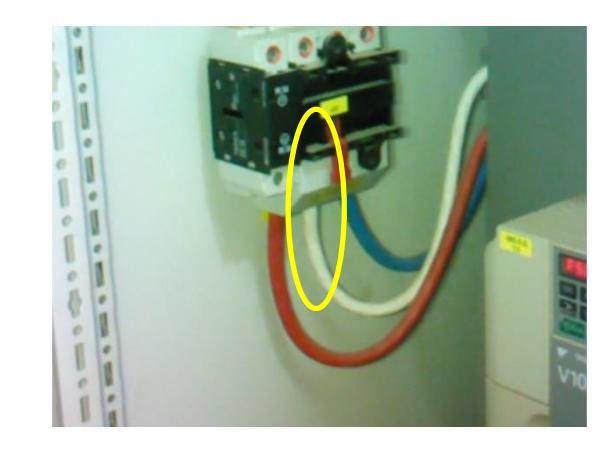
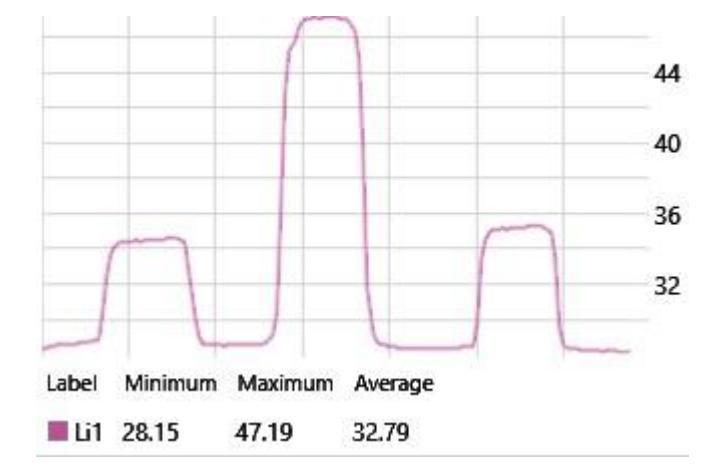
IR_17927.jpg | 09-Jan-19 | 8:35 AM

Measurements	
Sp1	33.6 °C
Bx1 Maximum	47.6 °C
Bx1 Minimum	28.1 °C
Dt1 (Bx1.Max - Sp1)	14.0 °C

Investigate further as soon as possible, repair/replace/explain as needed.

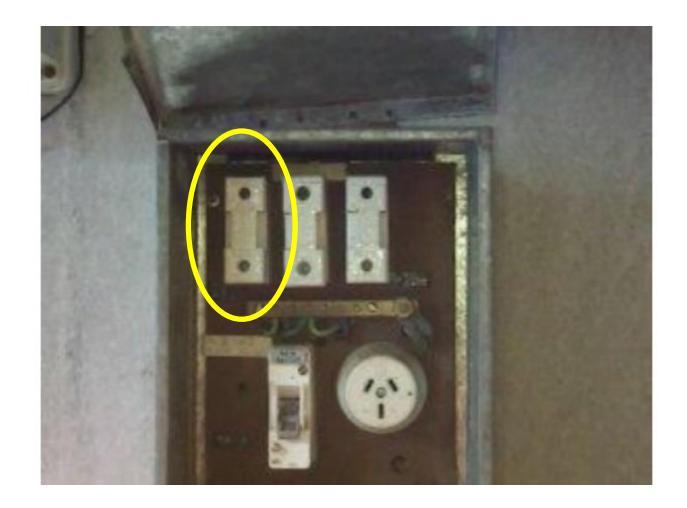
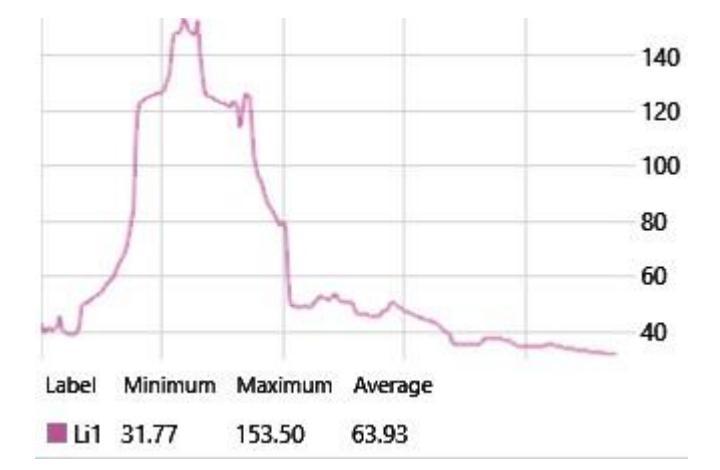
IR_0780b.jpg | 13-Feb-13 | 4:18 PM

Measurements	
Sp1	30.5 °C
Bx1 Maximum	160.2 °C
Bx1 Minimum	34.3 °C
Dt1 (Bx1.Max - Sp1)	129.7 °C

Investigate now, repair/replace/explain immediately.
